1540 – Hungry Point Reserve, Cronulla  
Conservation Management Plan  
June 2019

## 1540 | Hungry Point Reserve, Cronulla – Conservation Management Plan

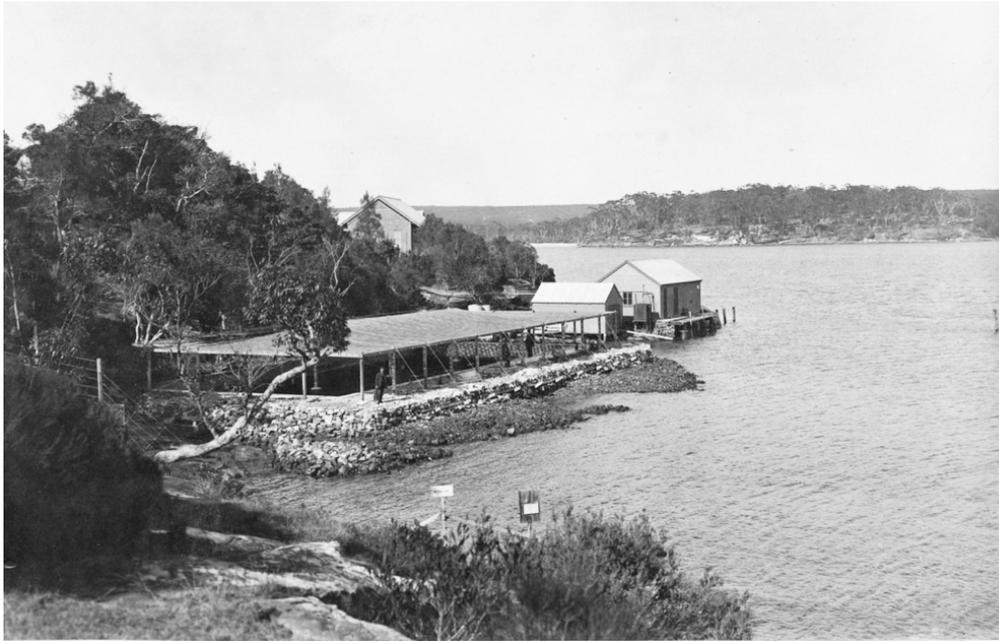
Figure 2.2.7 | 1908 | Gunnamatta Bay Hatchery on completion from Darook Park (Aquaria Fish Pond B23, Boat Shed B11, and former Boatshed MA4) Dannevig in Foreground | Dennis Reid

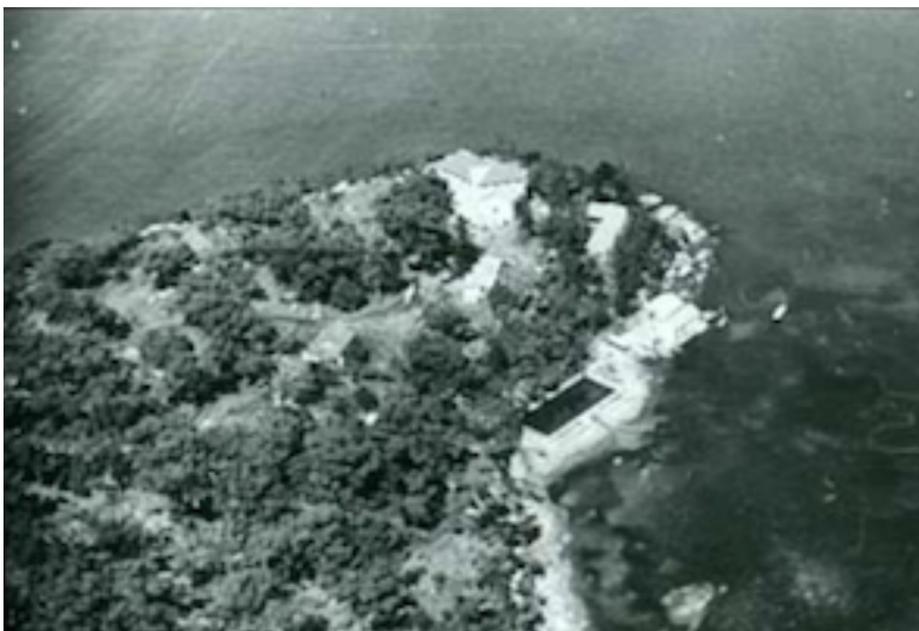
Figure 2.2.22 | c1939 | Aerial view of Fisheries buildings, indicating Former CSIR Fisheries Laboratory (B1) and Aquaria Fish Pond (B23) | National Archives of Australia

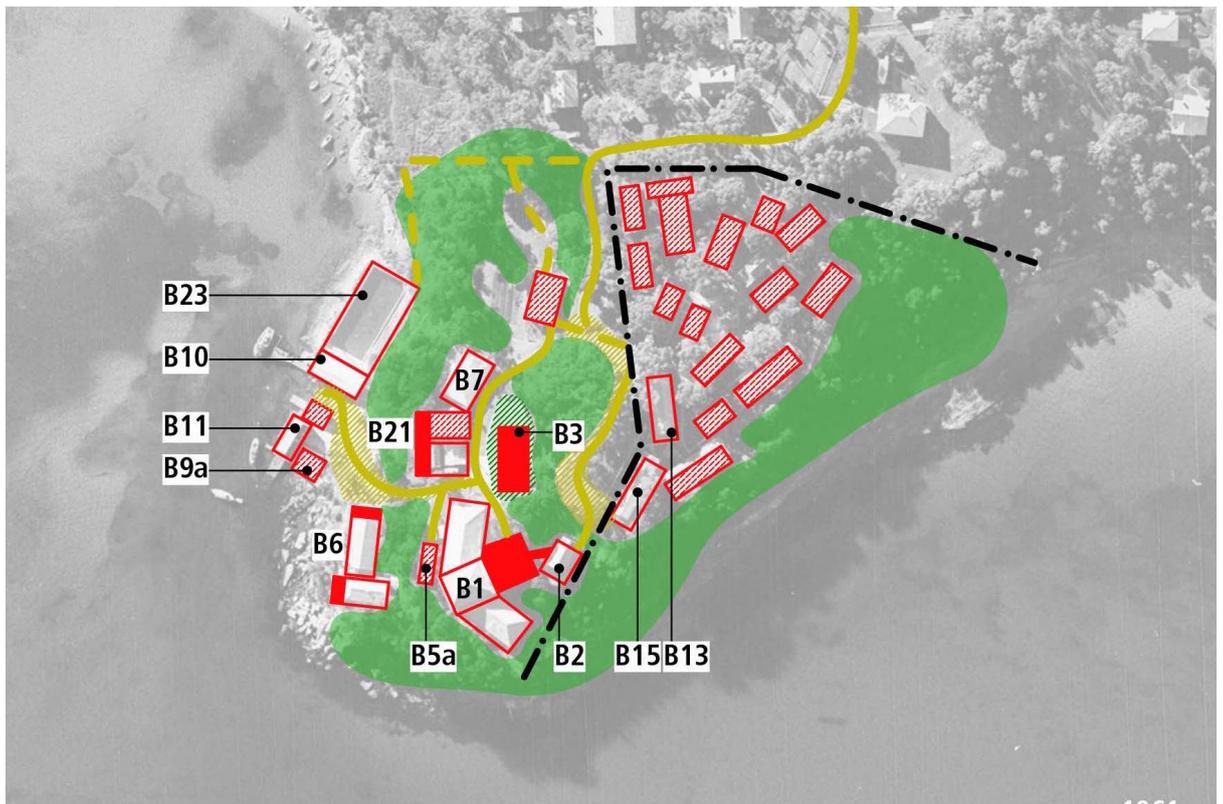
Figure 2.3.4 | 1961 | Aerial Map – Landscape, Path & Building Location | Architectural Projects

- B1 Former CSIR Fisheries Laboratory 1939
- B2 Computer Room 1940
- B5a Field Store 1940, Demolished Shed 1985
- B6 Former Hatchery 1904
- B7 Water Police/Fisheries School 1943
- B9a Cooler Shed 1930-40, Demolished Rebuilt in 1984
- B10 Former Fisheries School, Laboratory 1946
- B11 Boat Shed 1904
- B13 Former Migrant Hostel 1949-67
- B15 Former Migrant Hostel 1949-67
- B21 Header Tank (Refer Also MA6) 1904
- B23 Aquaria, Fish Pond 1904

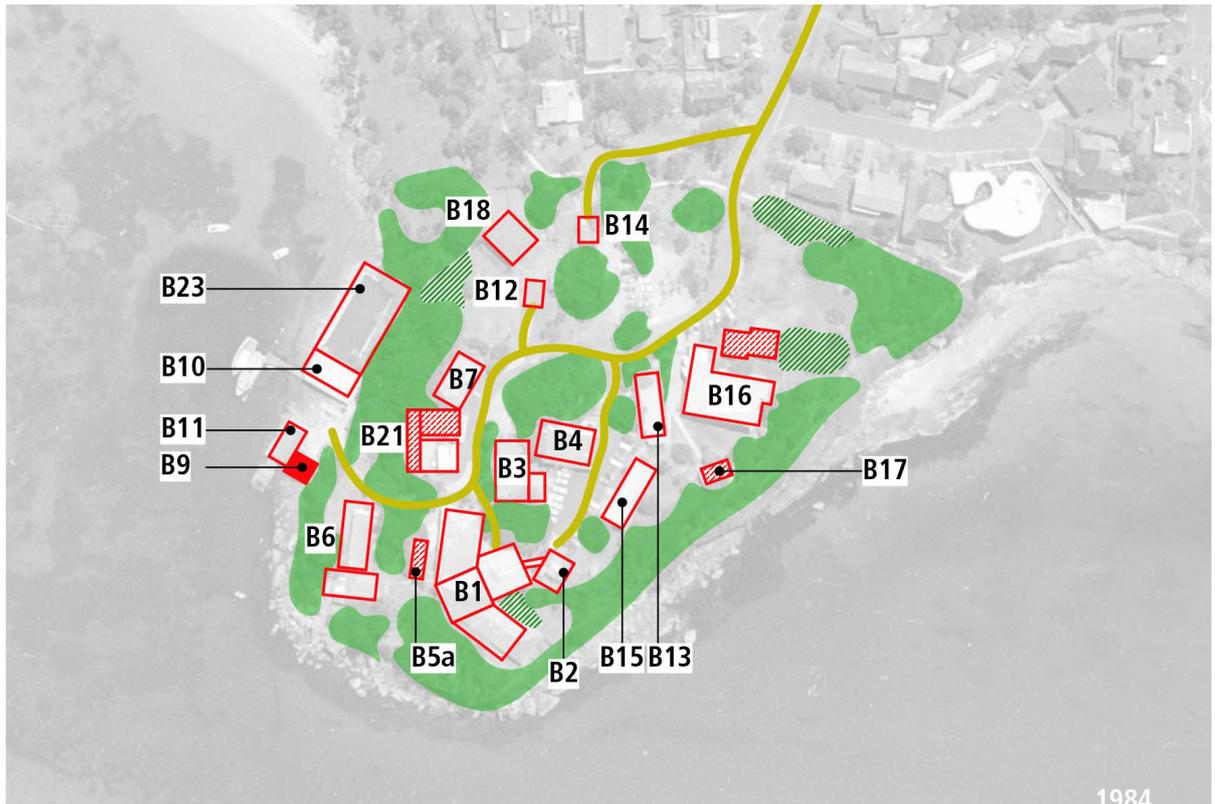
Figure 2.3.7 | 1984 | Aerial Map – Landscape, Path & Building Location | Architectural Projects

- B1 Former CSIR Fisheries Laboratory 1939
- B2 Computer Room 1940
- B3 Conference Room/Licensing 1950/1955
- B4 Records and Files 1960
- B5a Field Store 1940, Demolished Shed 1985
- B6 Former Hatchery 1904
- B7 Water Police/Fisheries School 1943
- B9 Cooler Shed 1930-40, Demolished Rebuilt in 1984
- B10 Former Fisheries School, Laboratory 1946
- B11 Boat Shed 1904
- B12 Garage 1971
- B13 Former Migrant Hostel 1949-67
- B14 Storage 1961
- B15 Former Migrant Hostel 1949-67
- B16 Commercial Management 1970
- B17 Chemical Store (demolished) 1970
- B18 Residence 1971
- B21 Header Tank (Refer Also MA6) 1904
- B23 Aquaria, Fish Pond 1904

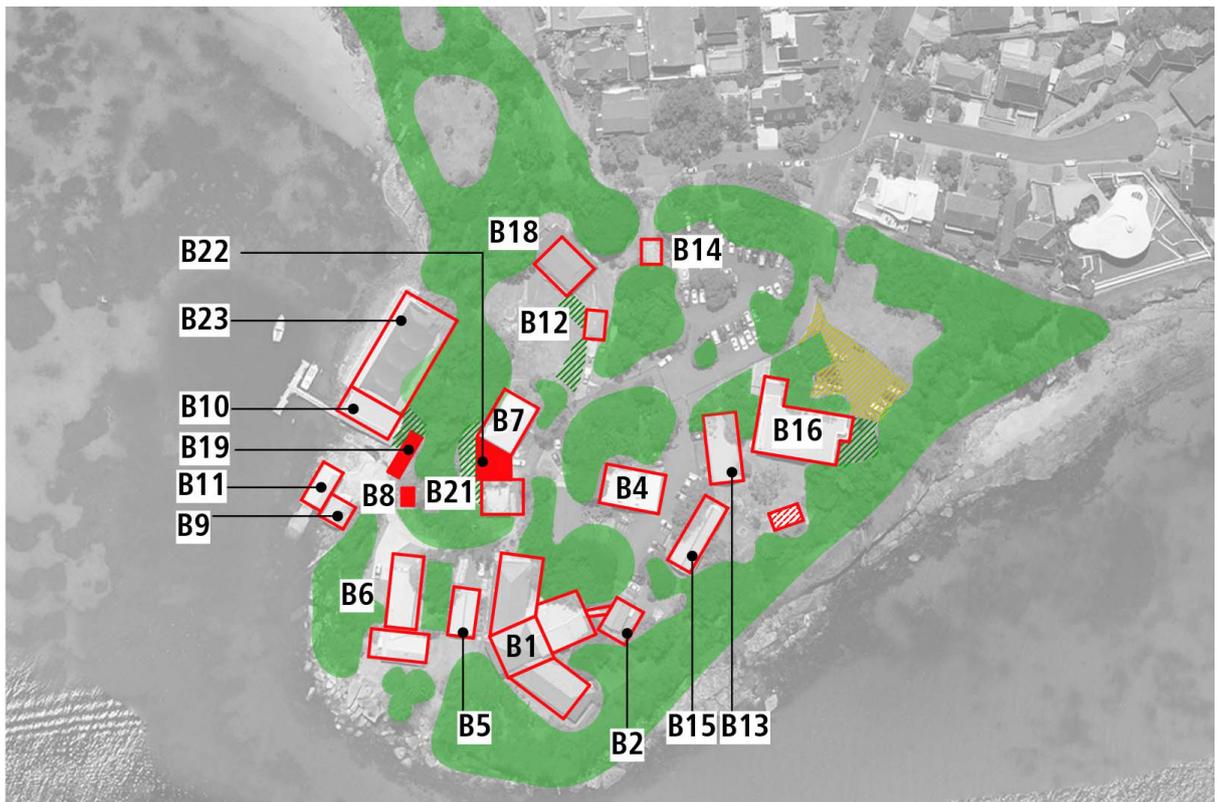
Figure 2.3.9 | 2006 | Aerial Map – Landscape, Path & Building Location | Architectural Projects

- B1 Former CSIR Fisheries Laboratory 1939
- B2 Computer Room 1940
- B3 Conference Room/Licensing 1950/1955
- B4 Records and Files 1960
- B5a Field Store 1940, Demolished Shed 1985
- B6 Former Hatchery 1904
- B7 Water Police/Fisheries School 1943
- B9 Cooler Shed 1930-40, Demolished Rebuilt in 1984
- B10 Former Fisheries School, Laboratory 1946
- B11 Boat Shed 1904
- B12 Garage 1971
- B13 Former Migrant Hostel 1949-67
- B14 Storage 1961
- B15 Former Migrant Hostel 1949-67
- B16 Commercial Management 1970
- B17 Chemical Store (demolished) 1970
- B18 Residence 1971
- B21 Header Tank (Refer Also MA6) 1904
- B23 Aquaria, Fish Pond 1904

The evolved landscape and buildings at Hungry Point express the interaction between land use and natural systems over time. The landscape extant today represents the accumulation of layers of change, without any overt comprehensive design intent, and as such it is considered to be a 'vernacular' landscape. Modification of the landscape followed the major phases of development for the site. An analysis of photographs, plans and historic aerials reveals the changing landscape character of the site. (Fig 2.3.1 – Fig 2.3.9)

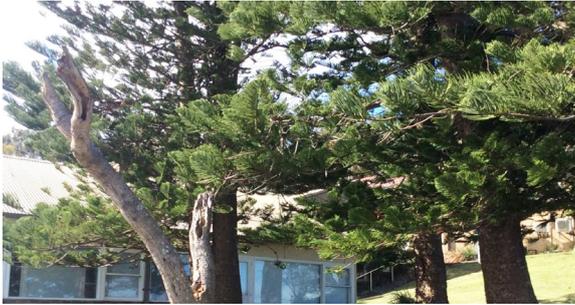
Figure 3.3.1 Cultural plantings and open space near Building 6 (T324, 325, 326)

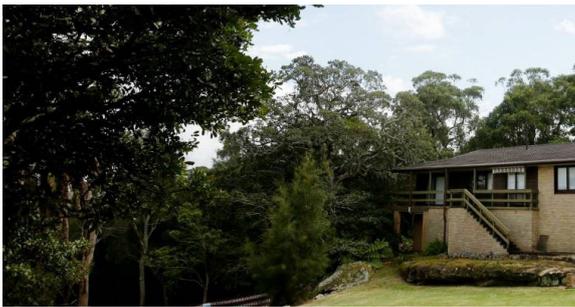
Figure 3.3.3 Open space and Port Jackson figs frame building 18 (T150)

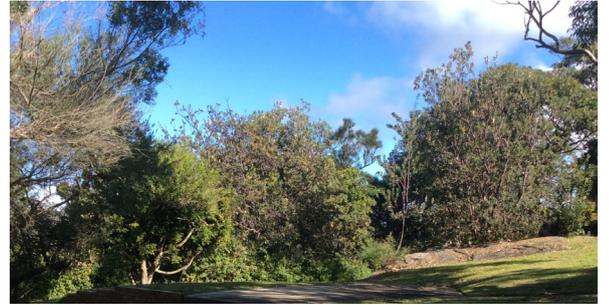
Figure 3.3.2 Open area at site of demolished Building 17

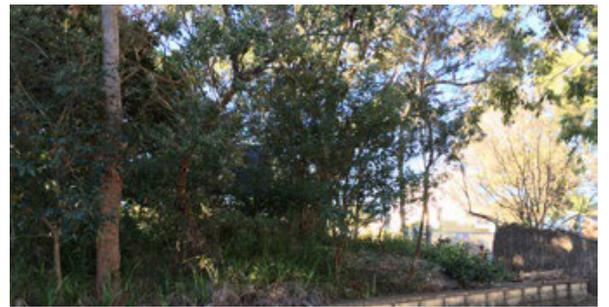
Figure 3.3.4 Remnant littoral forest adjacent to carpark

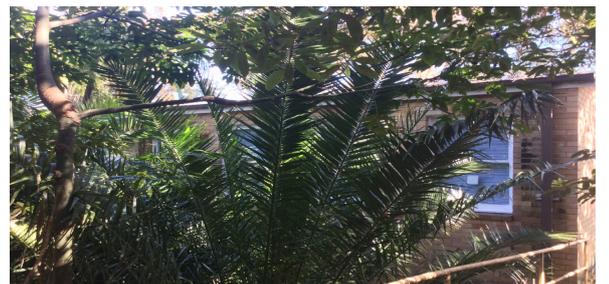
Figure 3.3.8 Self seeded Canary Island Palm (weed species) (T257)

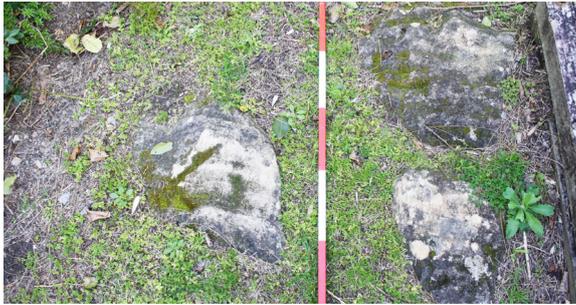
Figure 3.4.1 | MA10: Historic survey marker

The Historic Survey mark is located approximately 5m to 6m south-west of the southernmost corner of the main building on Hungry Point. The Historic Survey Mark indicates the Roman numeral co-ordinates. The Historic Survey Mark is slowly being covered over by grass. (Figure 3.4.1) The Historic Survey Mark is considered to be in a poor condition as the engravings have worn away and appear faded. The Historic Survey Mark is considered to be intact.

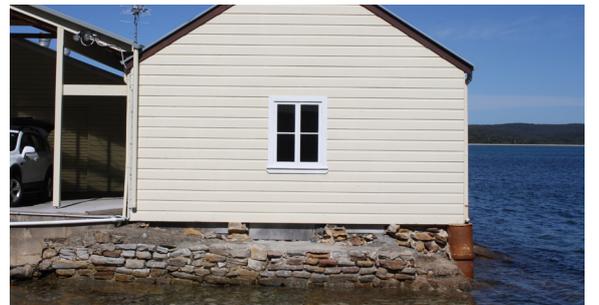
Figure 3.4.4 | MA1: Maritime Infrastructure

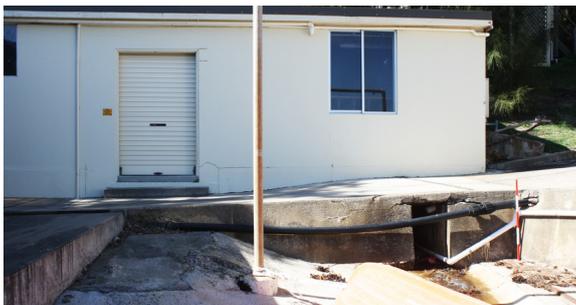
Figure 3.4.5 | MA3: 1904 Boatshed

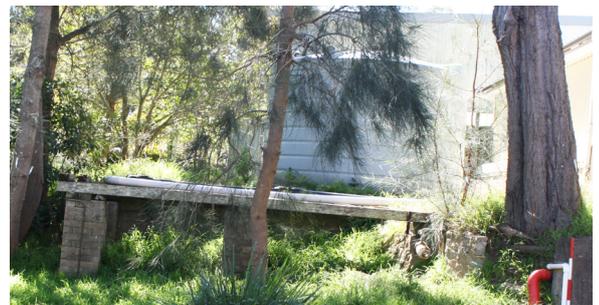
Figure 3.4.6 | MA6: Header tank

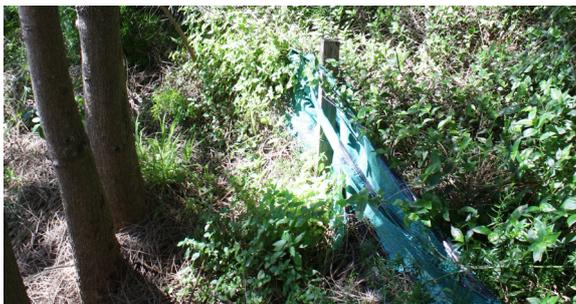
Figure 3.4.7 | MA6: Header tank

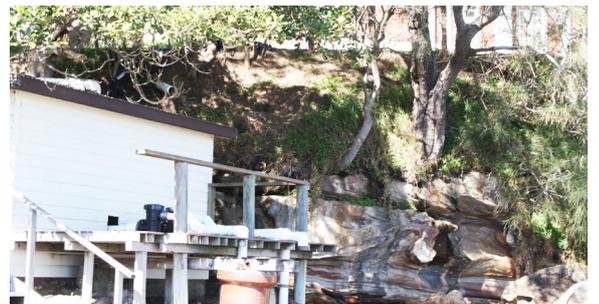
Figure 3.4.8 | MA8: Stone steps

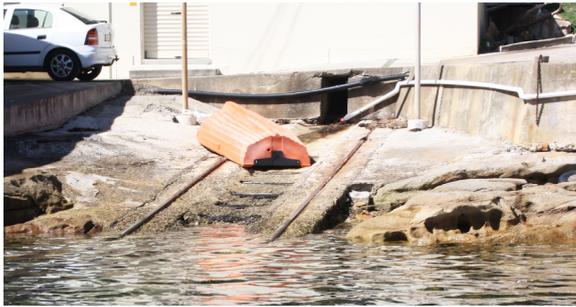
Figure 3.4.9 | MA2: Slipway

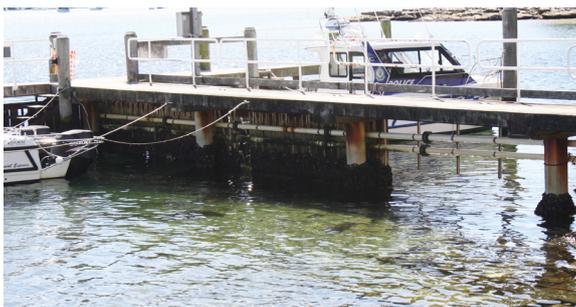
Figure 3.4.13 | MA5: Jetty

The first jetty constructed on the site was at the same time as the wet laboratory (Building 10) in c1945. By 1978 the jetty had been upgraded to include six mooring dolphins (three each side) were added to the end of the jetty to create a “T” head. This allowed for larger vessels to moor off the end of the jetty in deeper water. The jetty was demolished and replaced between 1985 and 1994 with the Current Jetty. Very few physical remains of the c1945 to c1990s jetty are present on the site. A section of cut down piles are visible from the current jetty on the seabed. There is the potential for maritime archaeological remains associated with this former jetty, being cut down piles, and possibly relics that have been accidentally dropped or discarded from this jetty to be present, however, these are likely to be limited in regards to quantity and research value given the limited use of this jetty. (Figure 3.4.13)

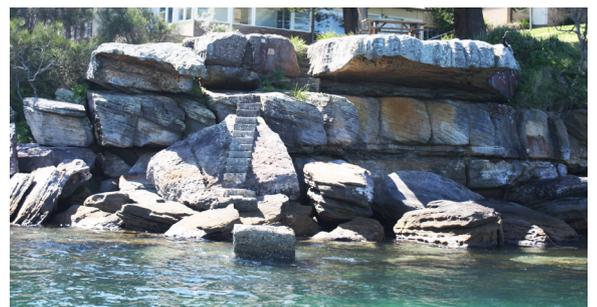
Figure 3.4.14 | MA9: Concrete Steps  
(former wharf)

The steps have been formed using concrete aggregate and are set into a crevice in the natural rock platform. There are two flights of stairs, the first set consist of 10 concrete formed steps leading from the top of the site down to the top of a rock overhang. A second series of steps leads from the rock landing down to the water’s edge. Approximately 3.5m in front of the last step is a concrete footing, used for the wharf platform. (Figures 3.4.14 and 3.4.15) The steps are in good condition, however the bottom two steps along the water’s edge have deteriorated through water and wave action. The concrete foundation is in poor condition. The steps are considered to be intact. The wharf/landing is damaged with the decking missing.

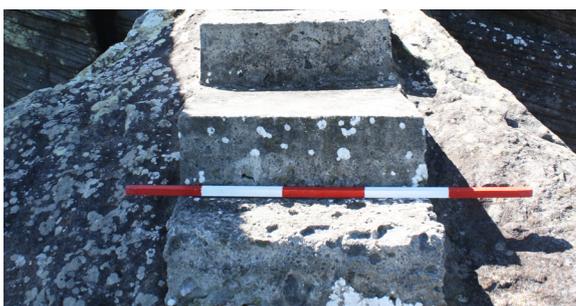
Figure 3.4.15 | MA9: Concrete steps detail

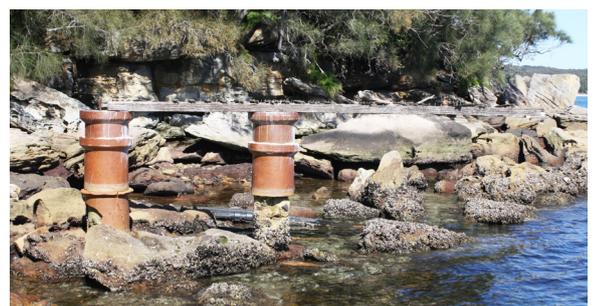
Figure 3.4.16 | MA7: Jetty/gantry

This structure first appears on a 1961 aerial photograph. Built over the rocky outcrop to the east of the boatshed (Building 11), the structure may have been associated with a trolley system or a narrow jetty/gantry used to load or unload boats at high tide. The remnant marine structure comprises of three still standing concrete-filled earthenware pipes and one that has collapsed. No foundation cut or postholes were present within the rock outcrop, indicating that they were built directly onto the rock outcrop. The earthenware pipes are the same foundation type used in the boatshed (Building 11). The earthenware foundations support two timber bearers with transverse timbers, and possibly with decking timbers on top. (Figure 3.4.16) This structure is in poor condition. This item is considered to be fragmented, with sections of the structure missing or fallen onto the rock platform. Only one section of the timber section of this structure is present.

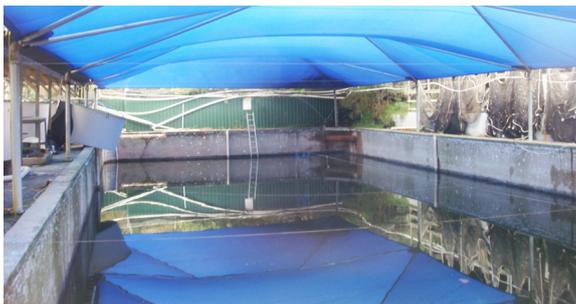
Figure 3.5.7 | Building 23: Aquaria (fish pond)

In 1904 the building was constructed as an Aquaria in the Hatchery period 1902-1914. It was converted to a fish pond. It has a direct functional relationship to Hatchery (Building 6). The 1930 aerial photograph first indicates the building. (Fig 3.5.7, 3.5.8)

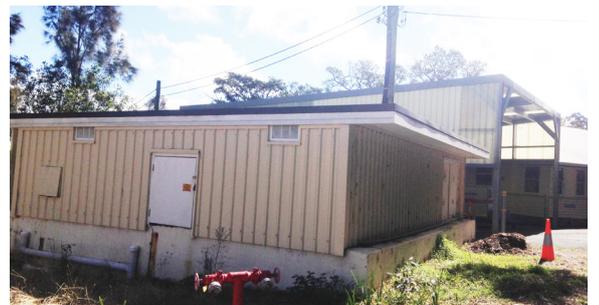
Figure 3.5.6 | Building 21: Header tank

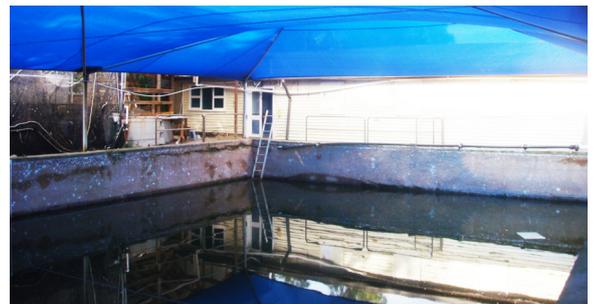
Figure 3.5.8 | Building 23: Aquaria (fish pond)

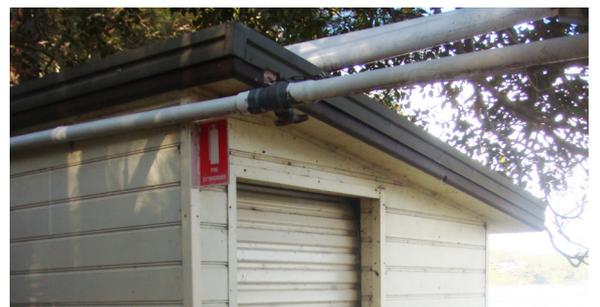
Figure 3.5.24 | Building 20: Pump shed

In 1955 the building was constructed as a Pump Shed in the CSIRO period. The 1961 aerial photograph first indicates the building. (Fig 3.5.24)

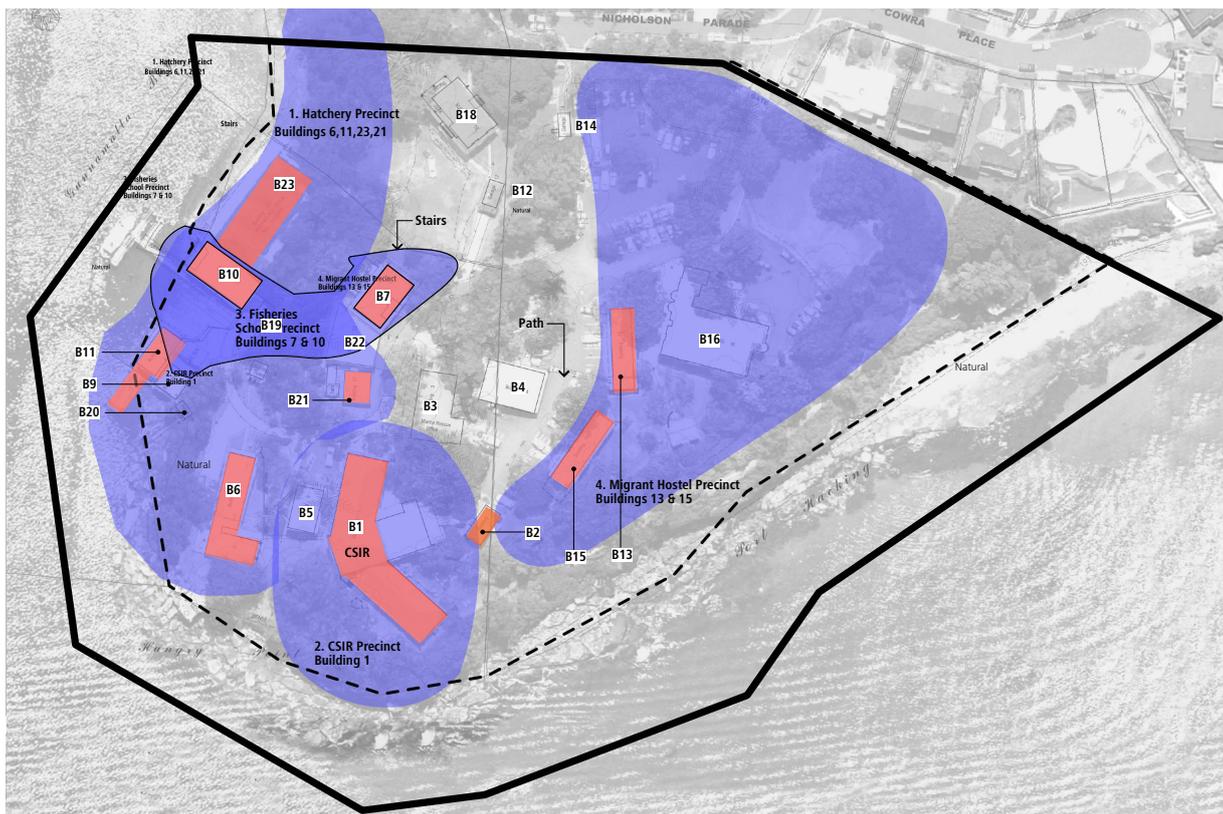
Figure 4.4 | 2017 | Significant Precincts and Proposed Heritage Curtilage | Architectural Projects

An expanded Heritage Curtilage that extends 30 meters out beyond the shoreline is recommended to include maritime infrastructure and archaeological sites beyond the tidal boundary, as well as protecting the maritime setting of the site and the relationship of the site to the water, aspects which contribute to the significance of the site.

Refer Figure 4.4 for Heritage Curtilage and Precincts relating to key periods of significance.

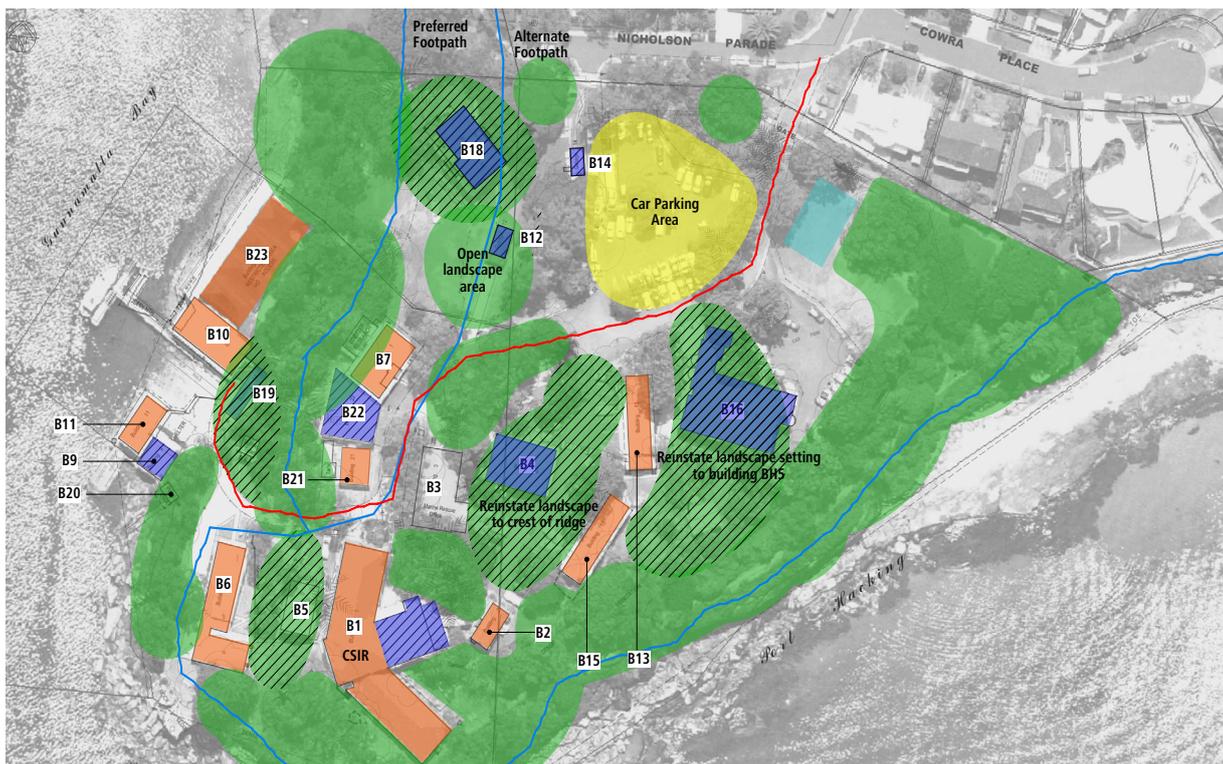
Figure 5.1 | 2017 | Opportunities | Architectural Projects

Refer Figure 5.1 Opportunities.

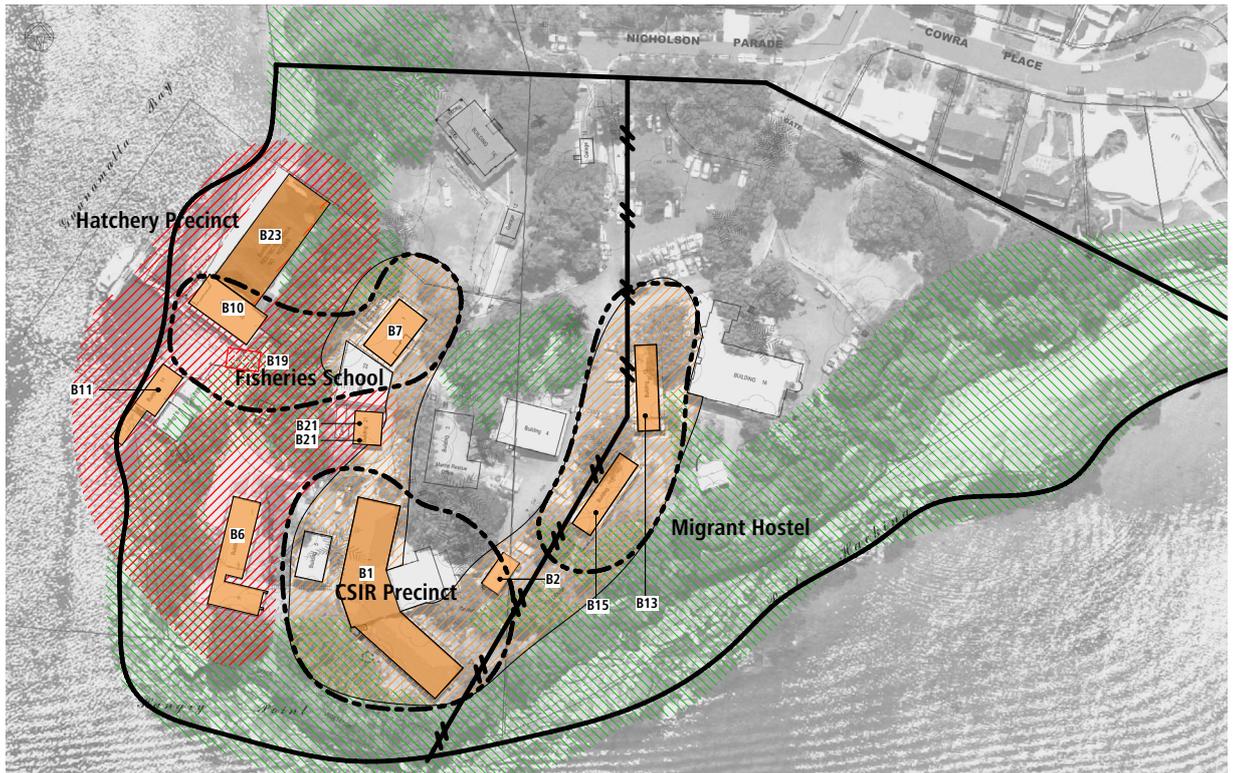
Figure 5.2 | 2017 | Potential for interpretation of the site | Architectural Projects

Refer Figure 5.2 showing areas with high potential for Interpretation of these Key Periods.

- Ongoing degradation of midden deposits between the grassed and vegetated garden areas, leading to erosion
- Ongoing impacts of informal use of the rock shelter in Area three, given its potential to retain subsurface archaeological deposits
- Ongoing degradation and destruction of exposed middens beneath building foundations by the dumping of refuse material.
- The site provides opportunities to interpret the Aboriginal heritage of the area and pre-European settlement period. These opportunities include interpretation of Aboriginal sites and remnant ecological groups. Refer Figure 5.2 showing the area with high potential for interpretation of the pre-European settlement period.

The potential of the site to interpret these key heritage values is greatest within the precincts that relate to the early key periods of development of the site. Refer Figure 5.2 Potential for Interpretation of Key Periods.

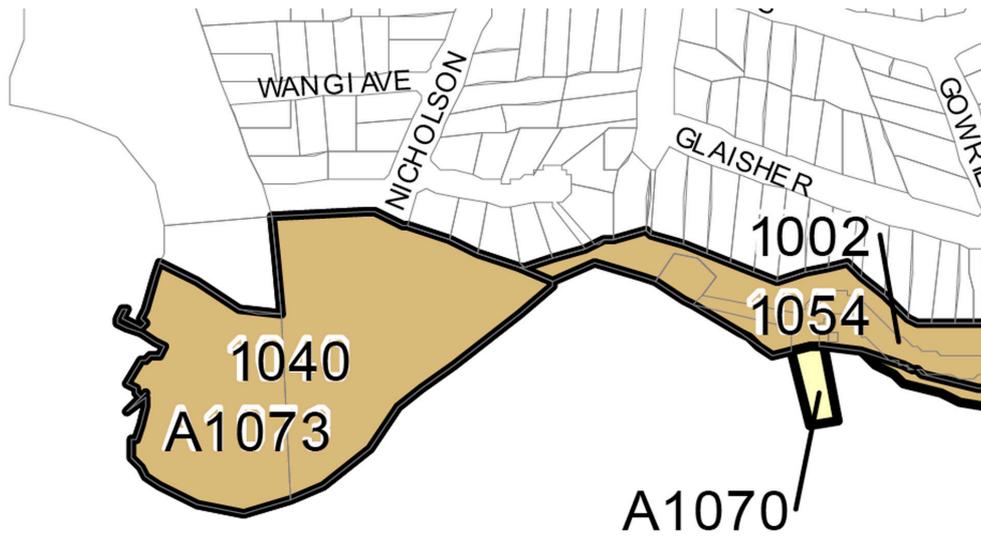
Figure 5.9.4 | 2015 | Sutherland Shire – Heritage map | Sutherland Shire Council

Flinders Point and Salmon Haul Reserve (L060K/1054), the walking paths on eastern foreshore (L059/1053, a remnant stand of Tuckeroo (T71/1002) and the remains of Salmon Haul Ocean Wharf (A027/A1070). (Refer Figure 5.9.4)

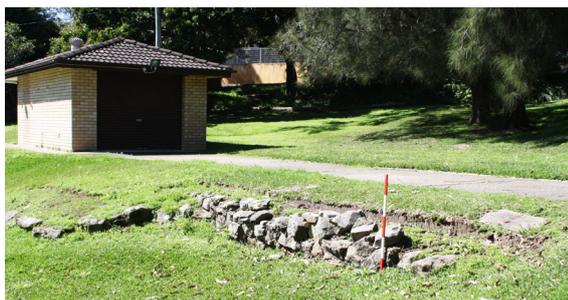
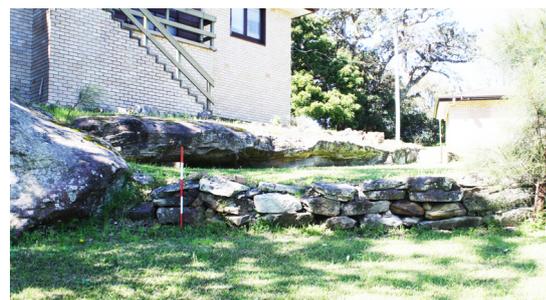
### 8.1. A1 – SITE OF FORMER CARETAKER’S COTTAGE – ARCHEOLOGICAL SITE

Inspection Date:	11/09/2014
Date Range:	c1904 (demolished 1970s)
Photo Index:	Figures 3.4.2 + 3.4.3
Latitude/Longitude:	-34.072483638 151.148421526
Current Use:	
Former Use:	
Proposed Use Short-Term:	
Proposed Use Long-Term:

The former Caretaker’s Cottage was located in the northern part of the site. The 1904 survey of the site shows a building of rectangular footprint of approximately 8 x 10m in size, oriented north-south. The survey also shows a verandah on each of the north and south faces and the outline of an area marked ‘excavated for drainage’. The former Caretaker’s cottage, later described as the Fisheries district inspectors residence at Cronulla, was thought to have been built on the site c1897, prior to the subdivision of the peninsula. It is described in 1939 as being...*“Built of hand-made bricks specially brought from England, bound together with English cement... The bricks are hollow and made of red clay. They are quite different from the usual household brick, being of peculiar shape, each having a tongue which fits into the adjoining brick. All walls of the cottage are of single brick width only, yet the whole structure is absolutely weather-proof”*. These unusual bricks described above may be E.L. Drew’s interlocking hollow brick, also used at the Hatchery (Building 6).

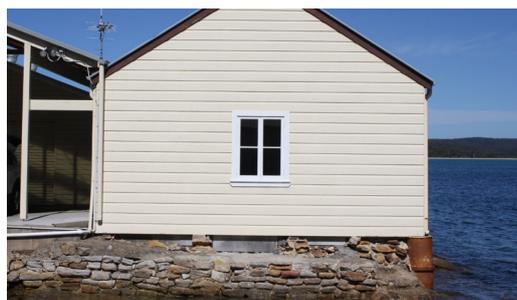
Inspection Date:	11/09/2014
Date Range:	c1904-1960
Photo Index:	Figure 3.4.4
Latitude/Longitude:	-34.072741361 151.147606135
Current Use:	No longer present
Former Use:	1904 Boatshed Maritime Infrastructure – used to service, load and repair Fisheries boats.
Proposed Use Short-Term:	N/A
Proposed Use Long-Term:	N/A

Historical Notes:	One of two boatsheds present in 1904, the boatshed (Building 11) extant, included two slipways, one built on the southern side of the building (still present at the time of this survey) and another built on the western side of the shed. During the 1940s mooring dolphins and a short jetty were added to this western side of the boatshed on the southern side of the slipway. All maritime infrastructure items built on the western side of the boatshed were removed by 1960.
Physical Description:	Maritime infrastructure associated with the 1904 boatshed (Building 11) were removed by 1960 and are no longer present. The slipway and short jetty present on the western side were built over a natural rock platform. This survey was conducted during low tide and did not find any evidence of posts or postholes present. It is possible that remains of the mooring dolphins are present on the seabed only. (Figure 3.4.4)

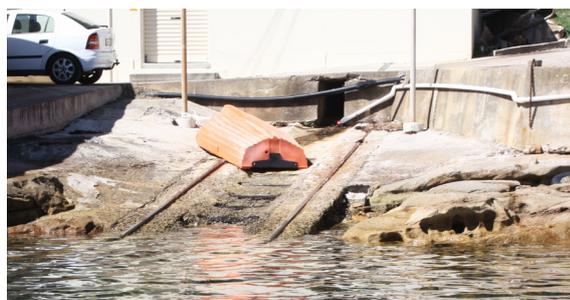
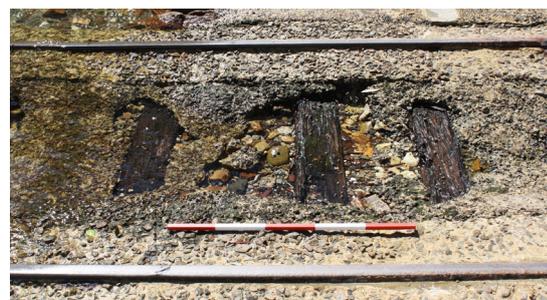
Inspection Date:	11/09/2014
Date Range:	c1920 to present
Photo Index:	Figures 3.4.9 + 3.4.10
Latitude/Longitude:	-34.072741361 / 151.147606135
Current Use:	1904 Boatshed slipway – still present but no longer in use.
Former Use:	1904 Boatshed slipway – used to raise one of three Fisheries boats out of the water. Remained in use after the 1904 Boatshed (MA3) was removed.
Proposed Use Short-Term:	Retain.
Proposed Use Long-Term:	Can be altered or removed if redevelopment in this area is proposed.

Historical Notes:	The 1904 plan of the site indicates that there were two boatshed present, one located to the northeast of the Hatchery Building (Building 11) and one located between the Hatchery Building and the Tidal Pond (annotated as “ <i>Old Boat Shed</i> ” and known as MA3 in this inventory). The slipway was added sometime around c1920.
Physical Description:	The slipway consists of two iron girders spaced 1.8m (6 ft) apart running on an east-west orientation. The remains of the slipway extend into the water and the visible extent of the slipway is approximately 16m long. The eastern end of the slipway has been built over with the current walkway surrounding the Diving Store (Building 19). Between the girders are timber sleepers, 0.18m wide that are irregularly spaced between 0.4m and 0.7m apart. Recent repairs to the slipway has seen both the inside and outside sections of the slipway encased in aggregate concrete, including sections that were underwater at the time of the survey. The girders are still present above the concrete repair work, but have degraded. (Figures 3.4.9 and 3.4.10)

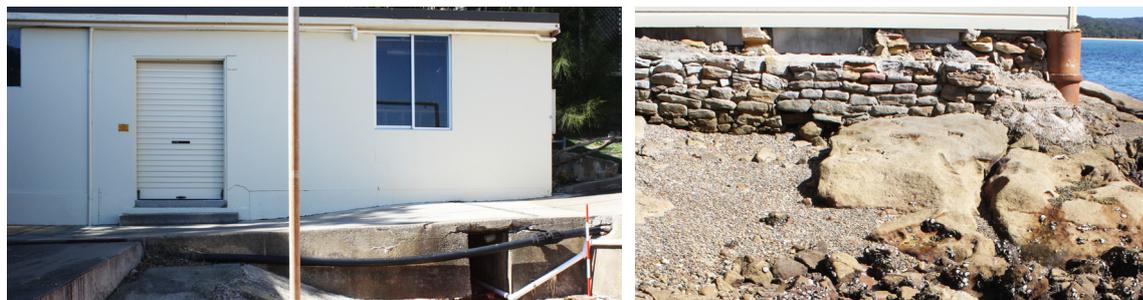
Inspection Date:	211/09/2014
Date Range:	c1902-1904
Photo Index:	Figure 3.4.5 + 3.4.12
Latitude/Longitude:	-34.072741361 / 151.147606135
Current Use:	Former 1904 Boatshed – no longer present.
Former Use:	Former 1904 Boatshed – used to house a skiff associated with the initial Fisheries establishment.
Proposed Use Short-Term:	N/A.
Proposed Use Long-Term:	N/A.

Historical Notes:	The 1904 plan of the site indicates that there were two boatsheds present, one located to the northeast of the Hatchery Building (Building 11) and one located between the Hatchery Building and the Tidal Pond (annotated as “Old Boat Shed”). This boatshed was built between 1902 and 1904, but was removed in 1904.
Physical Description:	The former Boatshed was demolished in 1904, and was situated at the eastern end of the slipway, underneath the Dive Store (Building 19). The ground level around the Dive Shop building has been raised by approximately 0.9m, with the Dive Shop likely to have been built on the ground level similar to the ground level of the Former Boatshed. The 1904 Boatshed was likely a timber framed structure that was present over the top of the eastern end of the slipway, indicating that it was a light-weight structure. No archaeological remains associated with this boatshed are expected to be present underneath the Dive Shop building. (Figure 3.4.5)

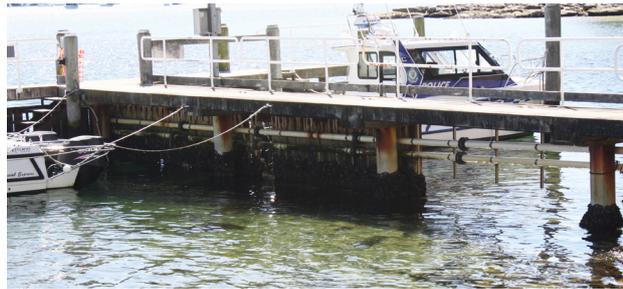
Inspection Date:	11/09/2014
Date Range:	1945
Photo Index:	Figures 3.4.13
Latitude/Longitude:	34.072741361 / 151.147606135
Current Use:	1945 West Jetty – No longer present. West Jetty – Still in use for Marine Rescue
Former Use:	1945 West Jetty – First jetty built on the site and later modified.
Proposed Use Short-Term:	Current Jetty to continue its current use.
Proposed Use Long-Term:	Current Jetty can be upgraded/modified/replaced as required or as necessary. Area between the wet lab and current 1904 boatshed (Building 11) could be used for future maritime structure.

Historical Notes: The first jetty constructed on the site was at the same time as the wet laboratory (Building 10) in c1945. By 1978 the jetty had been upgraded to include six mooring dolphins (three each side) were added to the end of the jetty to create a "T" head. This allowed for larger vessels to moor off the end of the jetty in deeper water. The jetty was demolished and replaced between 1985 and 1994 with the Current Jetty.

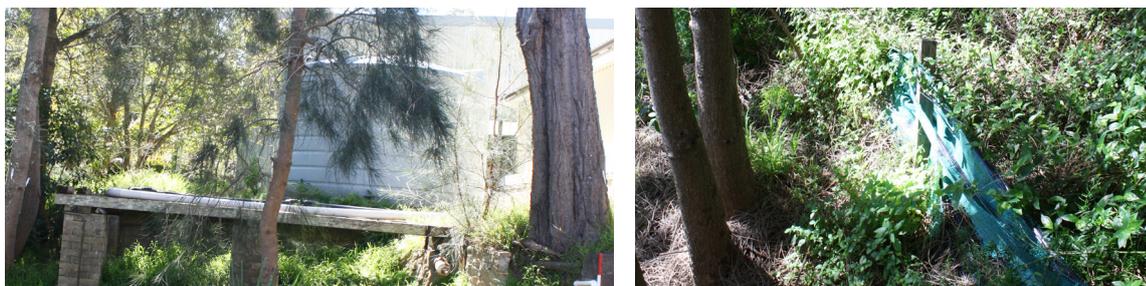
Inspection Date:	11/09/2014
Date Range:	1961
Photo Index:	Figures 3.46 + 3.4.7
Latitude/Longitude:	-34.072877999 / 151.148050041
Current Use:	
Former Use:	Used to supply seawater to the necessary buildings
Proposed Use Short-Term:	To be retained.
Proposed Use Long-Term:	To be retained with the option to remove the modern above ground structure.

Historical Notes:	The structure referred to as the header tank appears to be the original storage tank shown on the 1904 survey. The tank was used to store sea water which had been pumped from the bay. It was then distributed around the site to various locations where it was required. A valve associated with the tank is located down the slope from the tank. It has been refurbished and enclosed but is not in current use.
Physical Description:	The header tank is an open, rectangular, concrete tank of 8.57 x 7.1m in size. It is built into the ground with a low wall (approximately 0.5m) projecting about the ground level. A colorbond clad shed with a flat roof, no windows and roof ventilation covers over the header tank. Towards the southeast, between the storage tank and the Hatchery Building and immediately above the cutting for the access road, are the remains of a brick and timber inspection portal that houses a valve for the former 3" overflow pipe. This pipe connects with the water pipe to the Hatchery Building. The portal is approximately 1.2m long and 0.6m wide and is cut back into the slope of the hill. The location of the former water wheel at the back of the header tank behind the "1904 Boat Shed" (MA3), is currently overgrown with grass and vegetation and was not visible. (Figures 3.4.6 and 3.4.7)

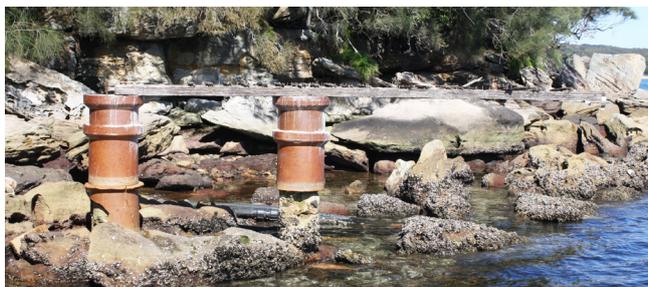
Historical Notes:	This structure first appears on a 1961 aerial photograph. Built over the rocky outcrop to the east of the boatshed (Building 11), the structure may have been associated with a trolley system or a narrow jetty/gantry used to load or unload boats at high tide.
Physical Description:	The remnant marine structure comprises of three still standing concrete-filled earthenware pipes and one that has collapsed. No foundation cut or postholes were present within the rock outcrop, indicating that they were built directly onto the rock outcrop. The earthenware pipes are the same foundation type used in the boatshed (Building 11). The earthenware foundations support two timber bearers with transverse timbers, and possibly with decking timbers on top. (Figure 3.4.16)
Condition:	This structure is in poor condition.
Integrity	This item is considered to be fragmented, with sections of the structure missing or fallen onto the rock platform. Only one section of the timber section of this structure is present.

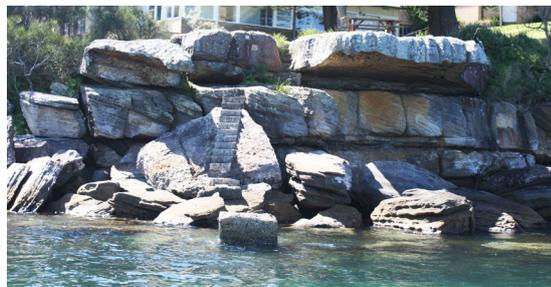
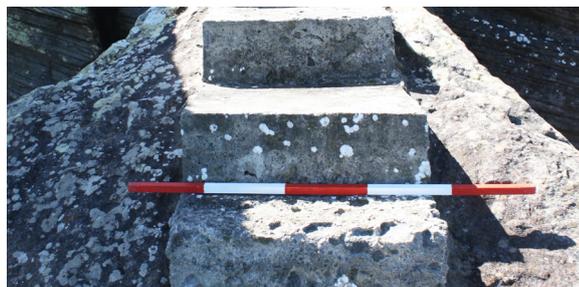
Historical Notes:	The wharf appears on aerial photos from the 1940s, and it can be assumed that the steps are contemporary with the presence of the wharf. The steps and wharf/landing were used almost exclusively by three friends, Dennis Stratford, Brian McClenaughan and Joseph Hatton. It is not known why these three people were given access to the controlled site. The wharf/landing appears to have been removed by the 1950s.
Physical Description:	The steps have been formed using concrete aggregate and are set into a crevice in the natural rock platform. There are two flights of stairs, the first set consist of 10 concrete formed steps leading from the top of the site down to the top of a rock overhang. A second series of steps leads from the rock landing down to the water's edge. Approximately 3.5m in front of the last step is a concrete footing, used for the wharf platform. (Figures 3.4.14 and 3.4.15)

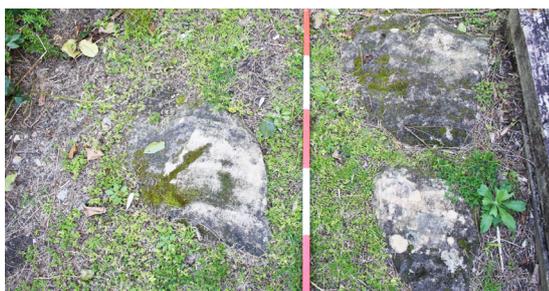
Historical Notes:	The survey mark is known by its Roman numeral name XXXII. This mark was placed during the 1800s and is a historic survey mark. There is also another mark located on a rock platform to the south-west of the Bass & Flinders Memorial which is known as XXXIV. There is a number engraved in the rock as "32" and not "XXXII". Some of the marks in the series around Port Hacking shoreline do not display an identifying number. <sup>93</sup>
Physical Description:	The History Survey Mark is located approximately 5m to 6m south-west of the southernmost corner of the main building on Hungry Point. The historic marker indicates the Roman numeral co-ordinates. The historic marker is slowly being covered over by grass. (Figure 3.4.1)
Condition:	The History Survey Mark is considered to be in a poor condition as the engravings have worn away and appear faded.
Integrity	The History Survey Mark is considered to be intact.

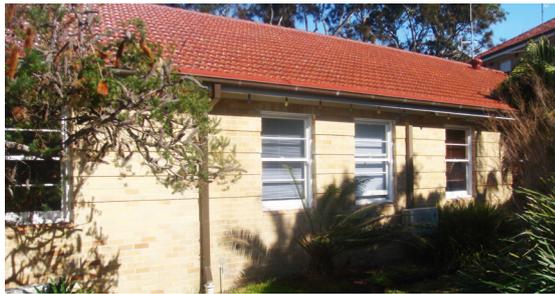
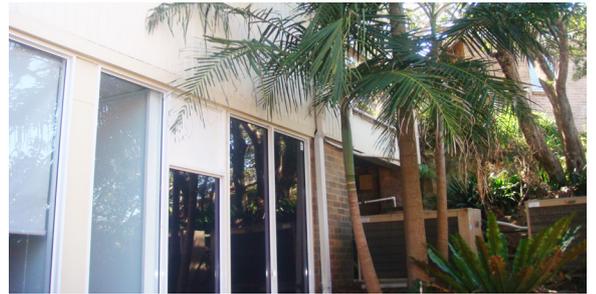
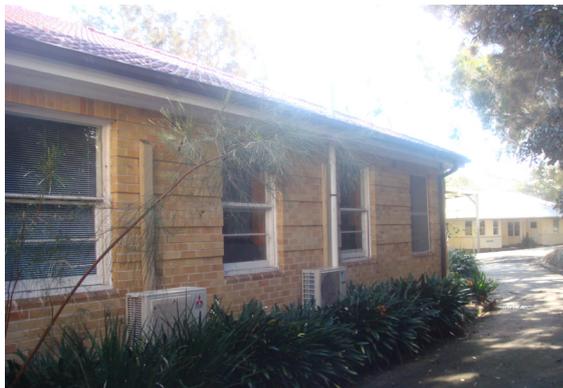
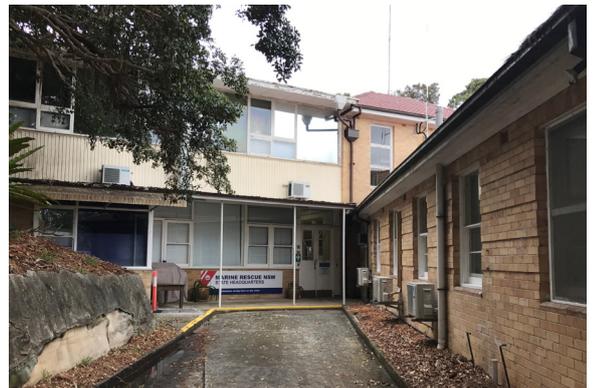
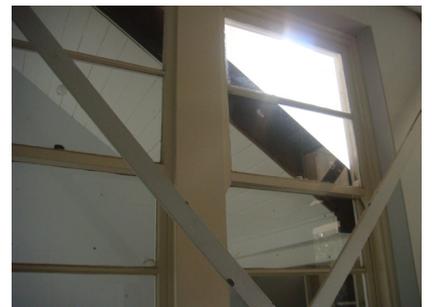
9.1. BUILDING 1 – FORMER CSIR FISHERIES LABORATORY

Inspection Date: 22/08/2014  
Date Range: South and Central Wings 1939  
North Wing 1940-1955  
East Wing 1955-1961  
Photo Index: Figures 3.5.9, DSCO 2396, 2430 +  
3.5.10, DSCO 2398, 3029, 2434,  
2450, 2454  
Current Use: Under licence to Marine Rescue  
Former Use: Library and Research  
Proposed Use Short-Term: Offices  
Proposed Use Long-Term: Offices, Residential Accommodation

In 1938 the Headquarters of the Fisheries Investigation Branch of the Council for Scientific and Industrial Research moved from Melbourne to Port Hacking in 1939. The construction of the central block offices, laboratories and library (Building 1) began in 1938. Dr H. Thompson stated the new laboratory would provide accommodation for the New South Wales Fish Biology Branch and for students from the University of Sydney, in addition to the staff of his department. Experimental equipment for the canning, smoking and refrigeration of fish would be provided.

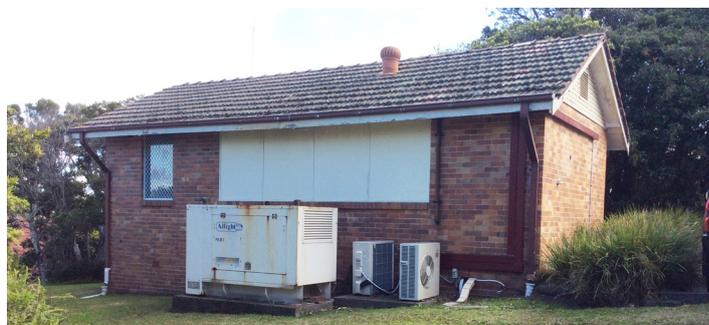
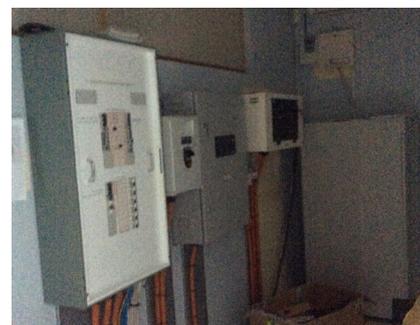
## 9.2. BUILDING 2 – COMPUTER ROOM

Inspection Date:	22/08/2014
Date Range:	c1940-1955
Photo Index:	Figures 3.5.11, DSCO 0140, 0143
Latitude/Longitude:	-34.073300129 / 151.148475841
Current Use:	Vacant – IT Hub, Under licence to Marine Rescue
Former Use:	Computer Services
Proposed Use Short-Term:	Retain for service use or demolish
Proposed Use Long-Term:	Retain or remove

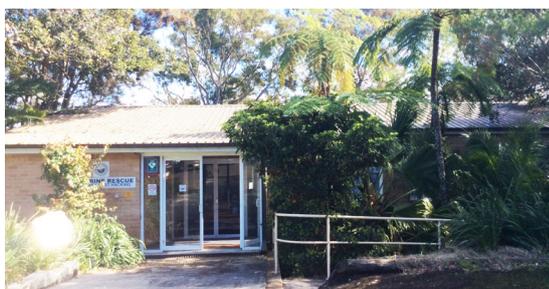
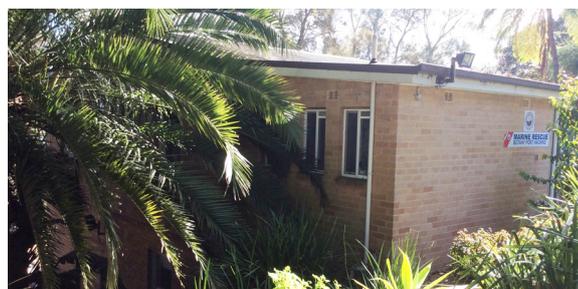
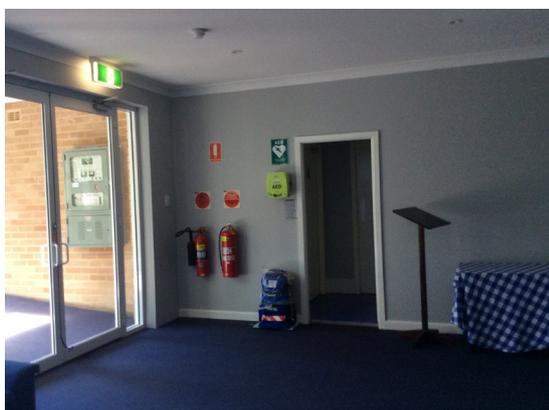
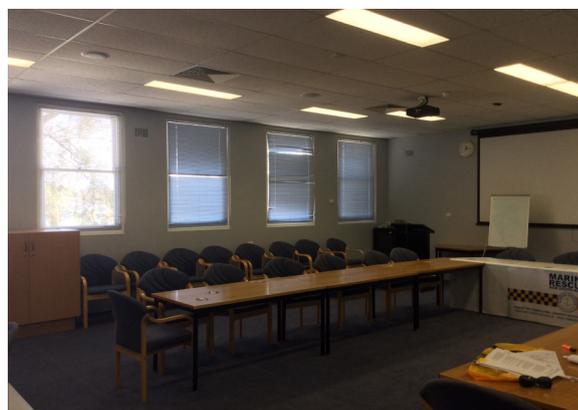
The building appears to be in good condition.

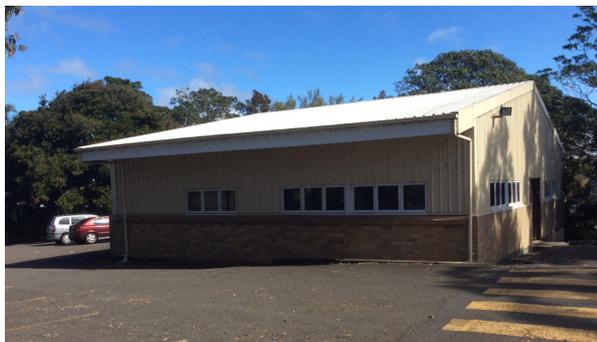
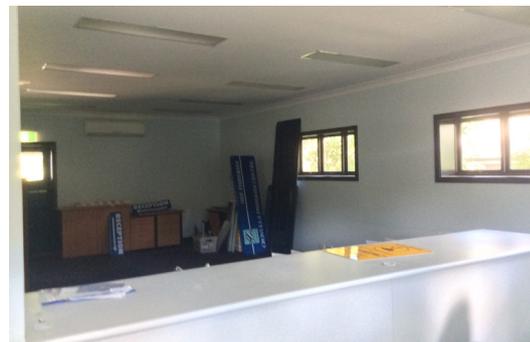
Inspection Date:	22/08/2014
Date Range:	1961
Photo Index:	Figure 3.5.19, DSCO 0099, 0107
Latitude/Longitude:	-34.072959092 / 151.148515404
Current Use:	Vacant
Former Use:	Records & Files
Proposed Use Short-Term:	Demolish
Proposed Use Long-Term:	Demolish

The building appears to be in good condition.

Demolition of the building is recommended.

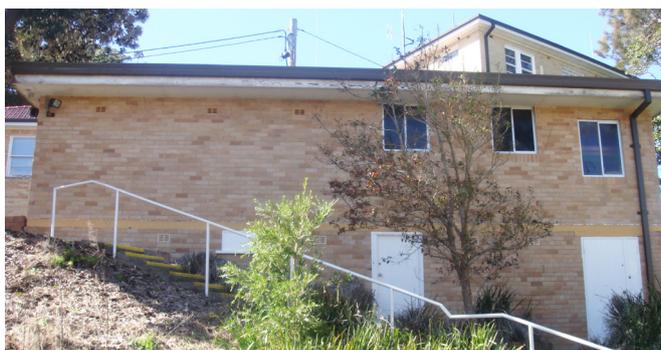
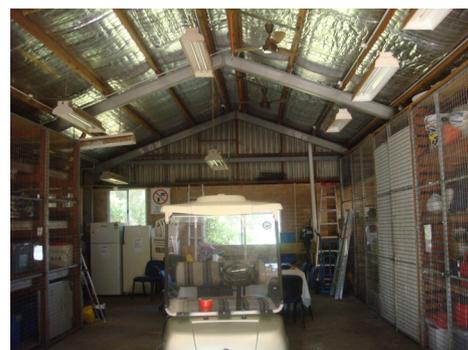
The building appears to be in good condition.

Retention is not required on heritage grounds. Demolition of Field store (Building 5) is recommended.
