1540 – Hungry Point Reserve, Cronulla  
Conservation Management Plan  
June 2019

## 1540 | Hungry Point Reserve, Cronulla – Conservation Management Plan

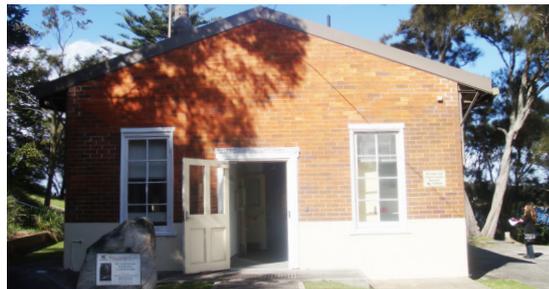
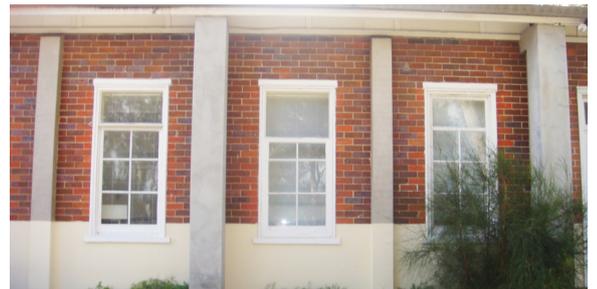
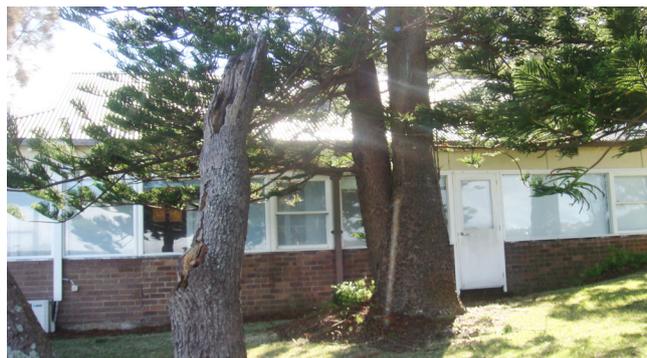
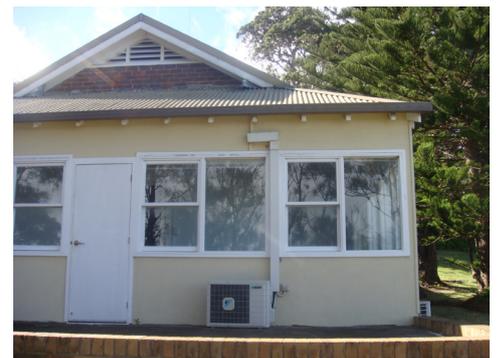
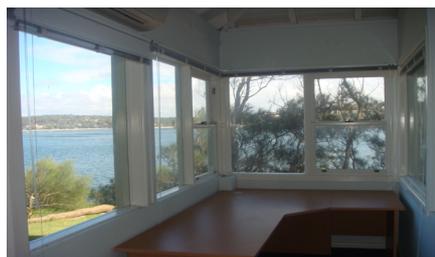
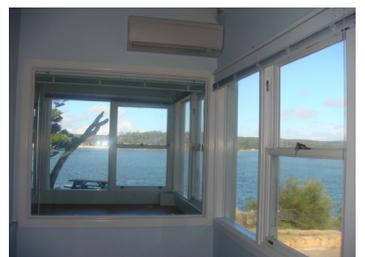
The building underwent restoration works in 2004 and is currently in good condition.

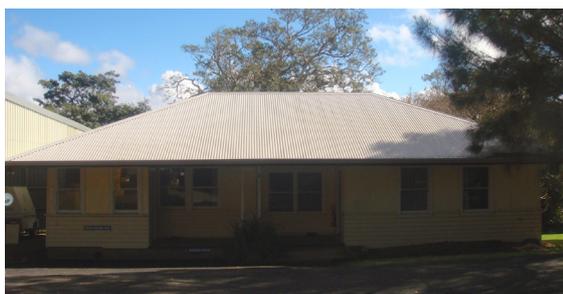
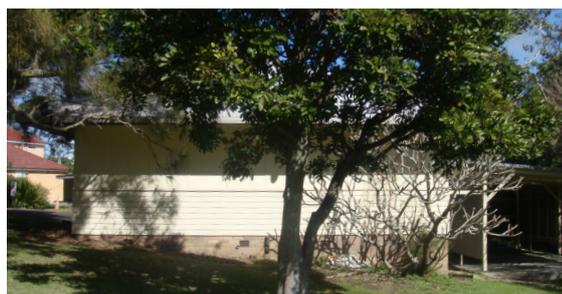
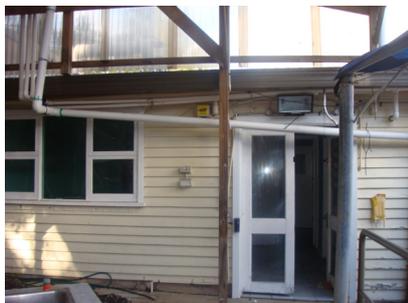
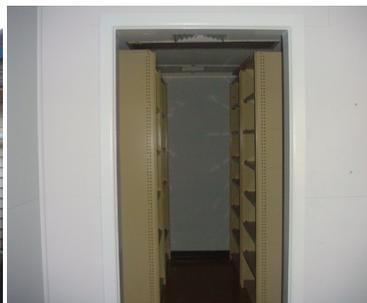
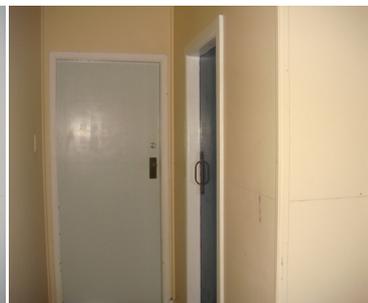
The building appears to be in good condition.

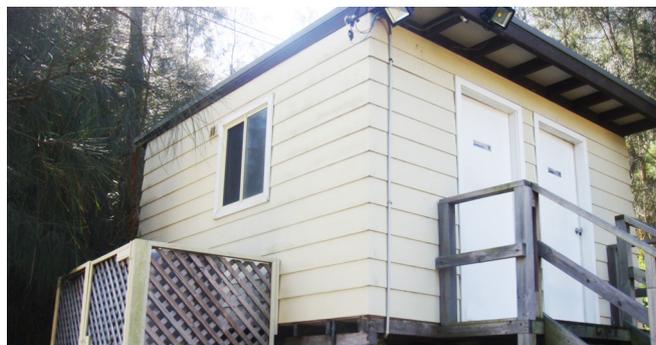
Inspection Date:	22/08/2014
Date Range:	1984
Photo Index:	Figure 3.5.27, DSCO 2336, 2333
Latitude/Longitude:	34.072966868 / 151.147773773
Current Use:	Toilets
Former Use:	Heat Exchange
Proposed Use Short-Term:	Toilet Facilities
Proposed Use Long-Term:	Demolish

The building appears to be in good condition.

Demolition of Toilet Block (Building 8) is recommended and should be considered when the building is not in use no longer required.

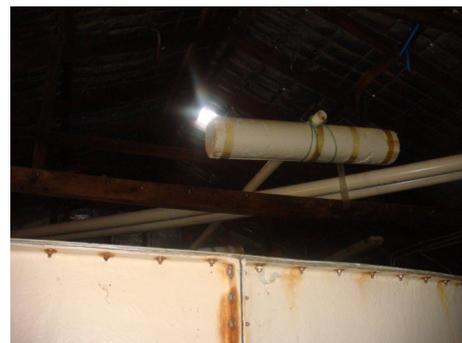
The building appears to be in good condition.

Cladding has been replaced yet the form of the building is intact.

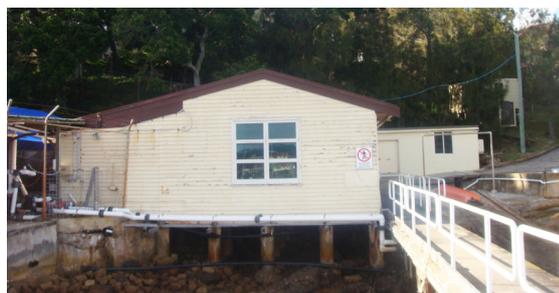
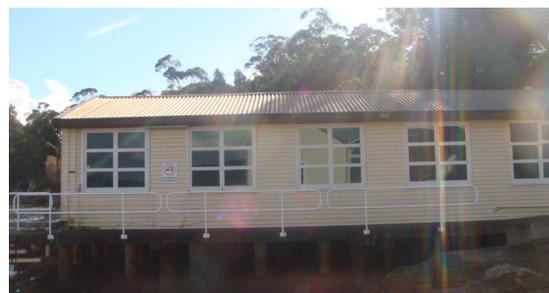
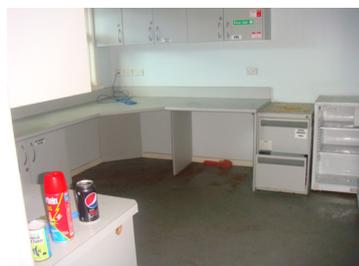
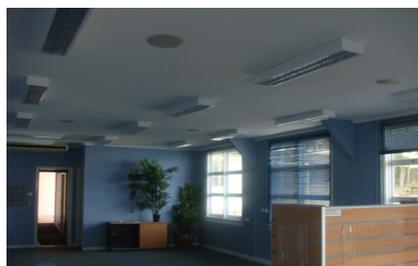
The building appears to be in good condition.

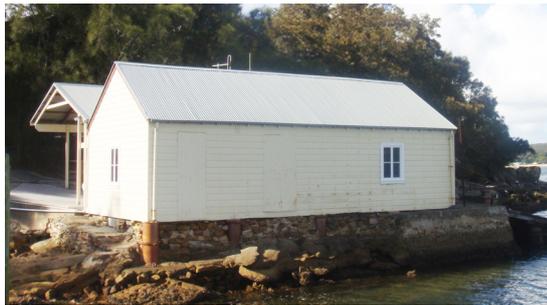
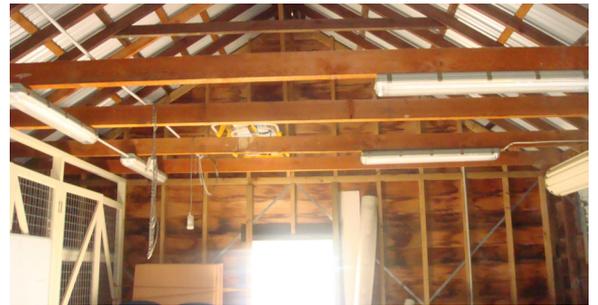
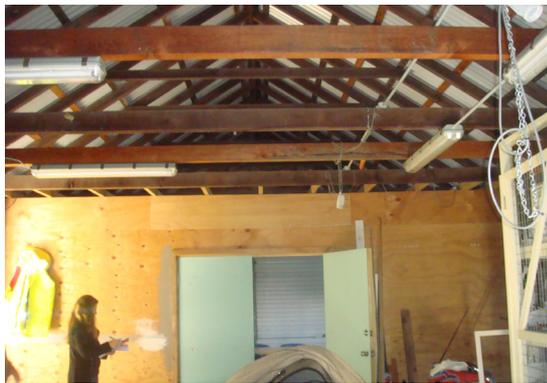
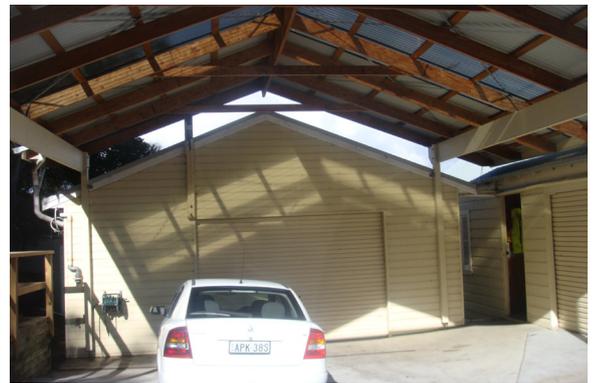
The building appears to be in good condition.

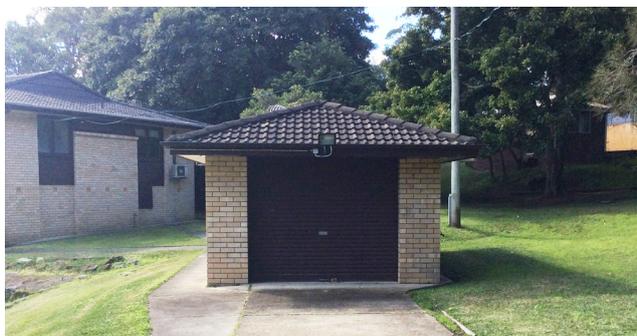
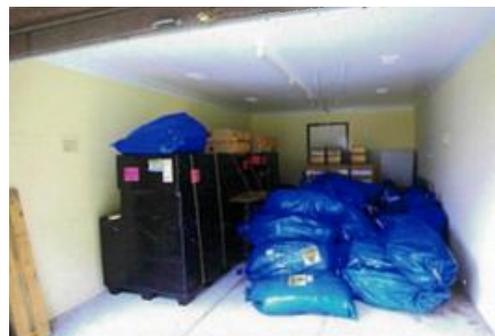
The building appears to be in good condition.

Demolition of Garage (Building 12) is recommended.

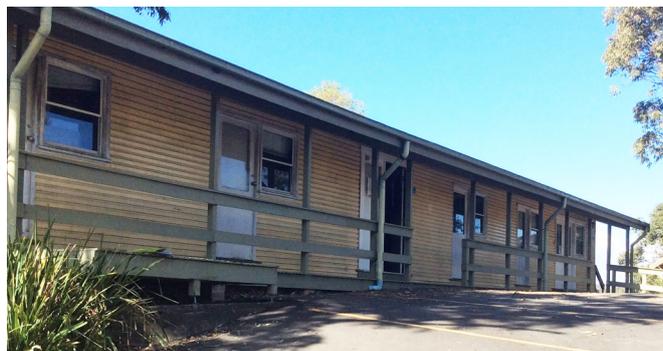
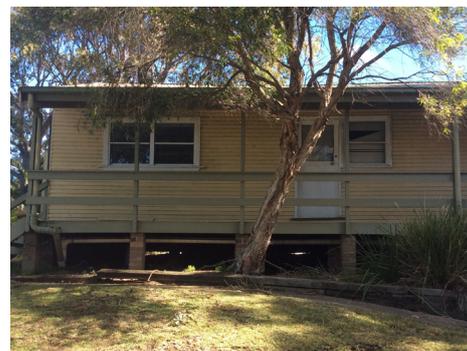
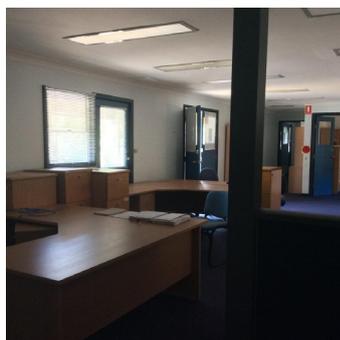
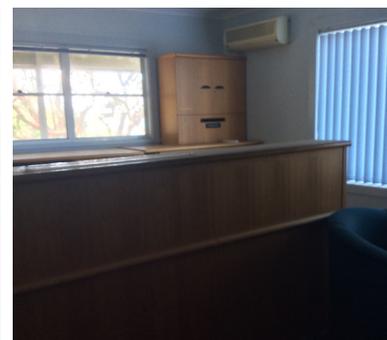
The building appears to be in good condition.

Alterations and additions include: interior refit, ramp access, some openings altered, some door leaves replaced, roof/guttering replaced.

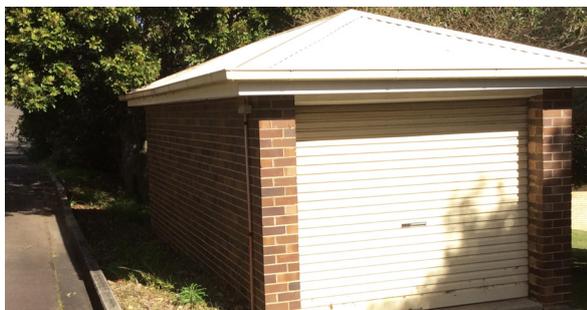
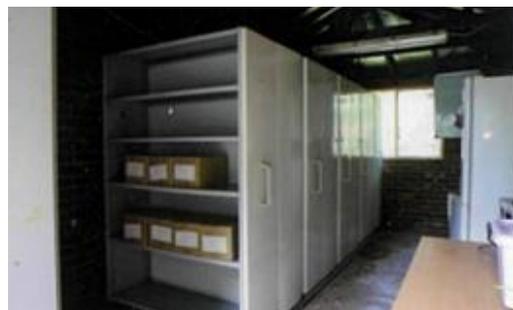
Inspection Date:	22/08/2014
Date Range:	1961-1970
Photo Index:	Figure 3.5.21, DSCO 0156, 0157
Latitude/Longitude:	-34.072288124 / 151.148611963
Current Use:	—
Former Use:	Storage/Garage
Proposed Use Short-Term:	Demolish or retain for storage
Proposed Use Long-Term:	Demolish

The building appears to be in good condition.

The building is below the threshold for inclusion in the Heritage Schedule of the LEP.  
Demolition is recommended to better interpret key periods of significance of the site.

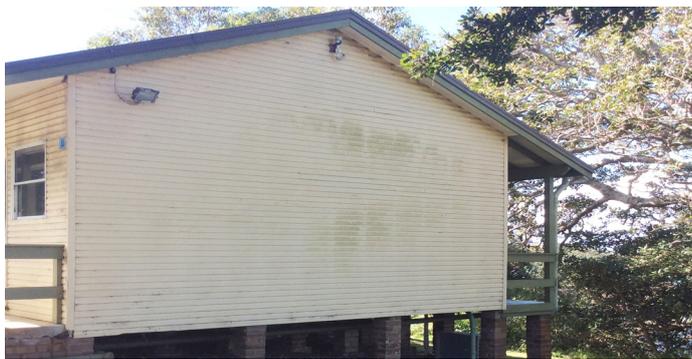
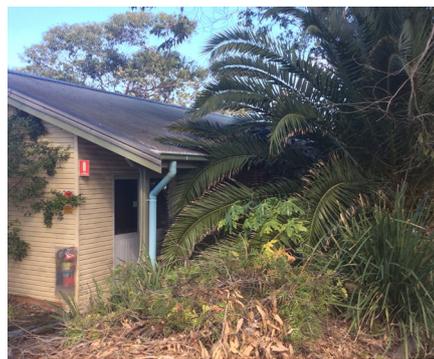
The building appears to be in good/fair condition.

Alterations and additions include: some contemporary partitions, some windows replaced, air conditioning units.

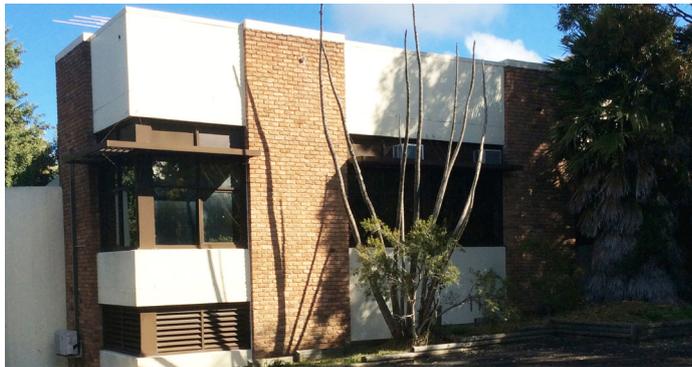
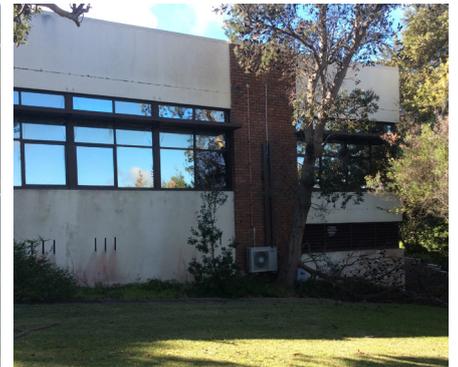
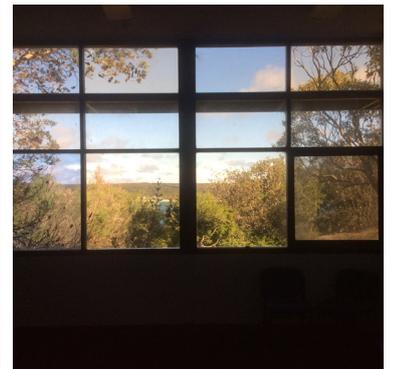
9.16. BUILDING 16 – COMMERCIAL MANAGEMENT

The building appears to be in good condition.

Demolition of Commercial Management (Building 16) is recommended in the long term and returns the site to a natural topography. Suitable short-term uses may be accommodated with minor upgrade.

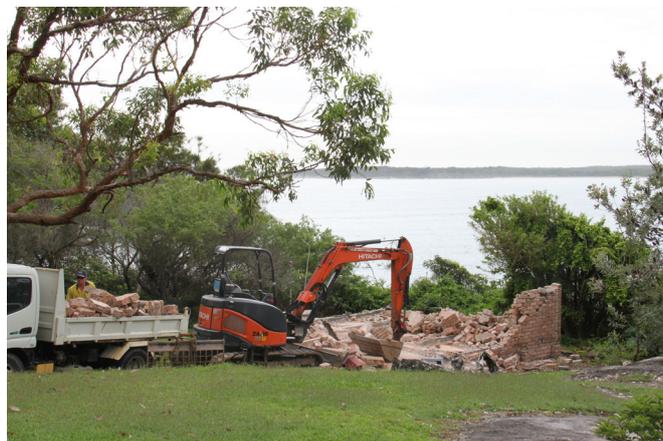
9.17. BUILDING 17 – CHEMICAL STORE (DEMOLISHED)

In 1974 the building was constructed as chemical store and demolished in 2013. The 1978 aerial photograph first indicates the building. The building replaced portable offices. Purpose built brick explosives store that was redeveloped as chemical store. The roof would blow out if an explosion occurred. It was demolished in 2013.

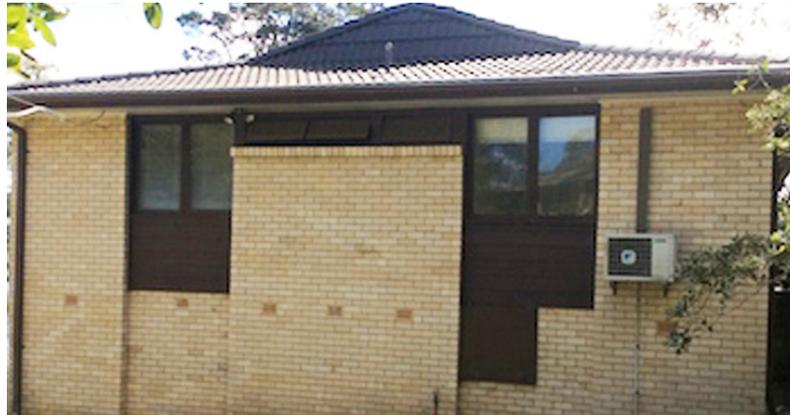
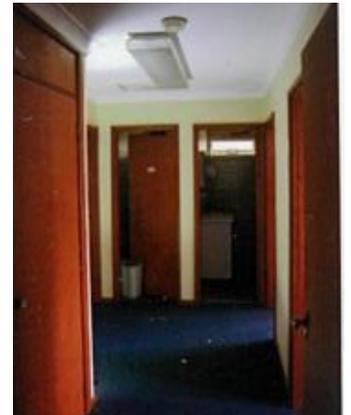
## 9.18. BUILDING 18 – RESIDENCE

The building appears to be in good condition.

Demolition of Residence (Building 18) is recommended.

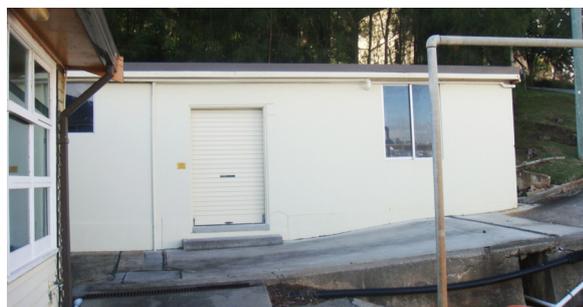
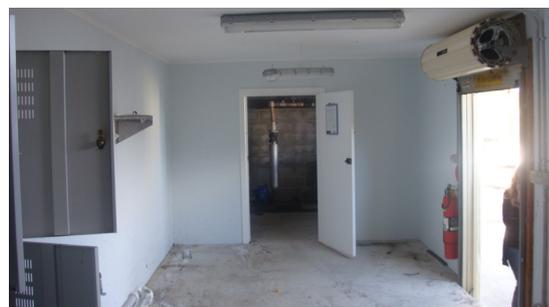
## 9.19. BUILDING 19 – DIVE STORE

The building appears to be in good condition.

Demolition of Dive Store (Building 19) is recommended.

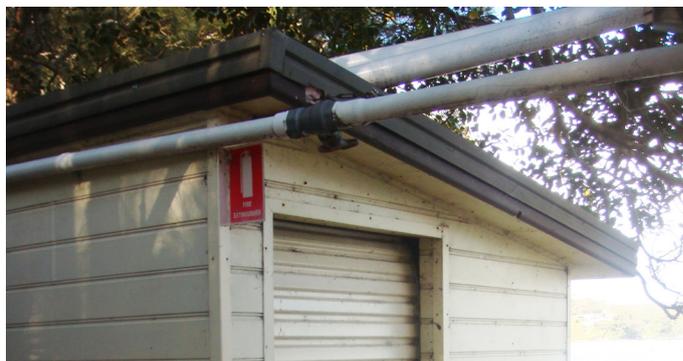
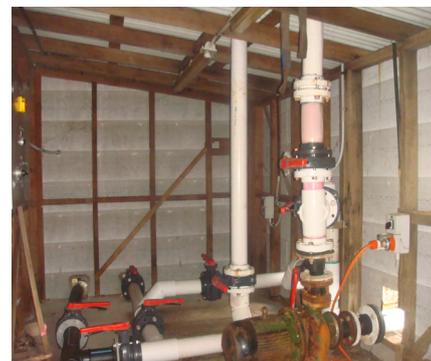
## 9.20. BUILDING 20 – PUMP SHED

The building appears to be in good condition.

Demolition of Pump Shed(Building 20) is recommended.

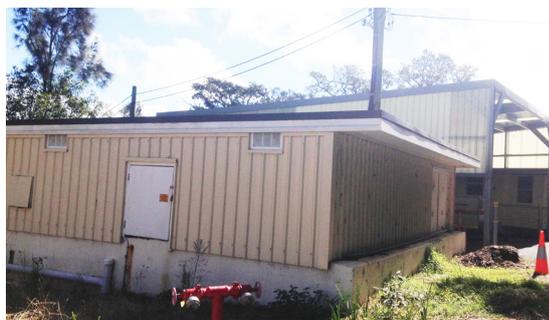
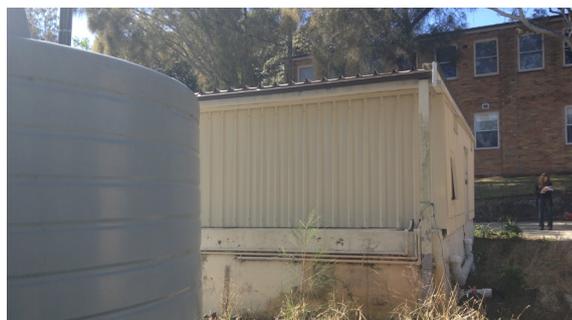
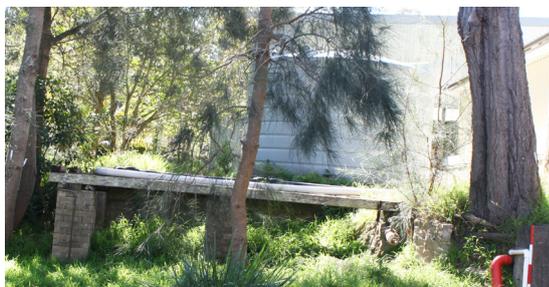
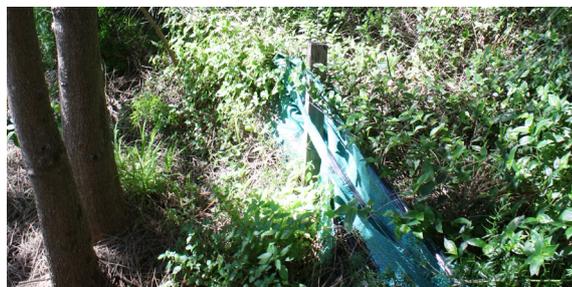
9.21. BUILDING 21 – HEADER TANK (REFER ALSO MA6)

The structure appears to be in fair/poor condition.

Retain, conserve and interpret the original fabric of the 1904 tank. Demolition of superstructure and further investigation of the original fabric of the tank is recommended.

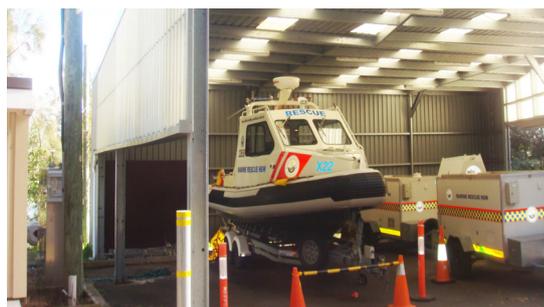
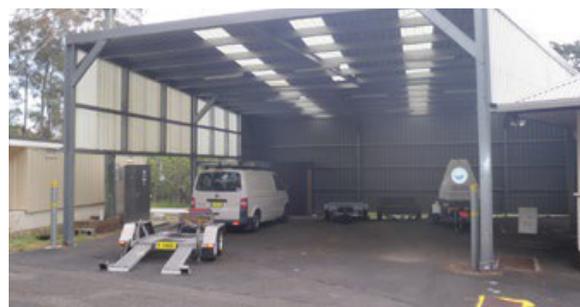
## 9.22. BUILDING 22 – BOAT STORAGE/GENERATOR SLAB

The structure appears to be in good condition.

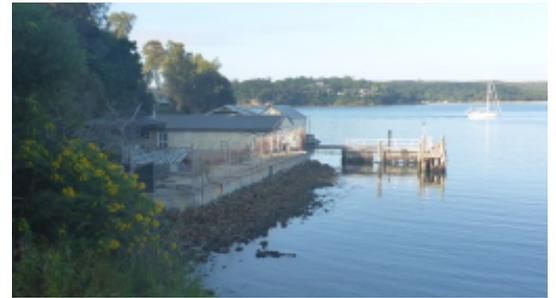
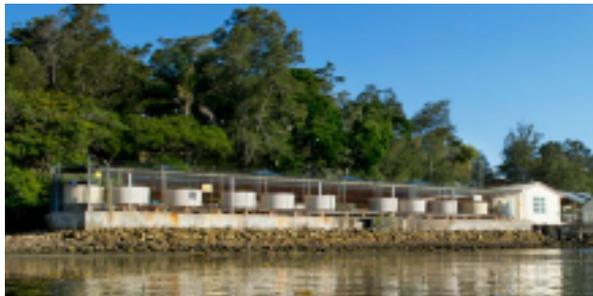
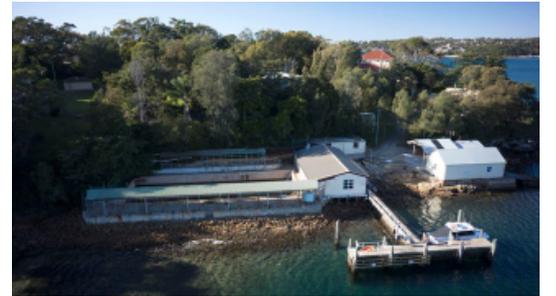
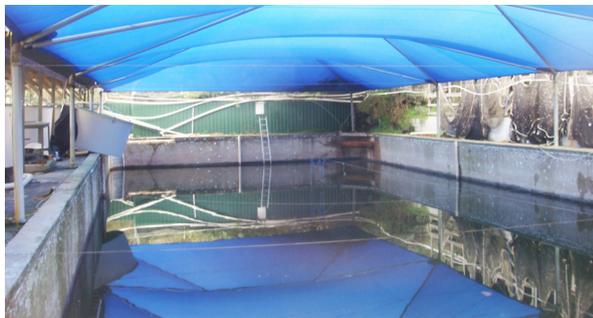
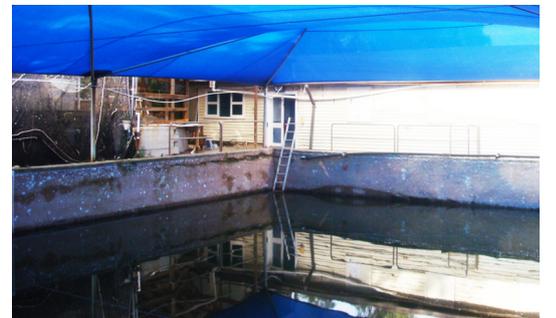
9.23. BUILDING 23 – AQUARIA, FISH POND

The structure appears to be in fair condition. The storm event of 16 December 2015 damaged the pool cover and structure.

accommodate tanks (now removed). New sea wall replaced original rubble retaining embankment. Original timber framed shading was replaced with a steel canopy (now removed). Storm event on 16 December 2015 caused damage to pool cover and structure. Insurance managed.

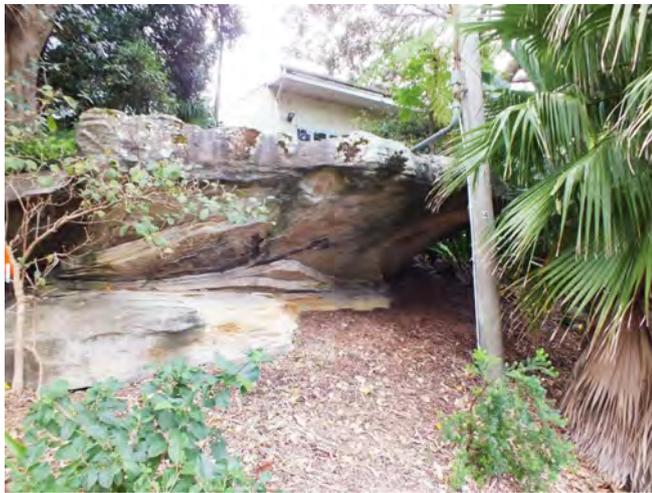
though minimal shell material was observed in front of the shelter within a dark brown/black sandy soil matrix (Figure 6.2-Figure 6.4). This shell material is obscured by introduced soil, mulch and leaf litter. It is likely that the midden deposit has been partially disturbed during construction of garden beds.

Figure 6.2 View east of the rockshelter in a garden bed, adjacent to Building 3.

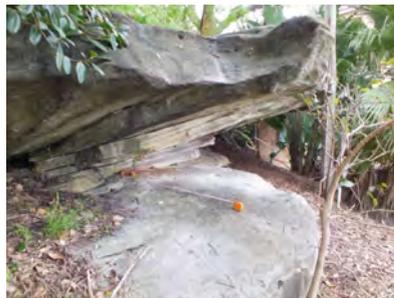
Figure 6.3 View south of bare rockshelter floor.

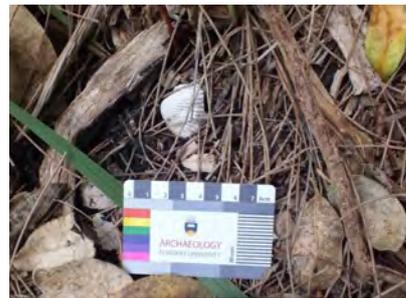
Figure 6.4 Detail of isolated cockle shell amongst leaf litter on floor of garden bed.

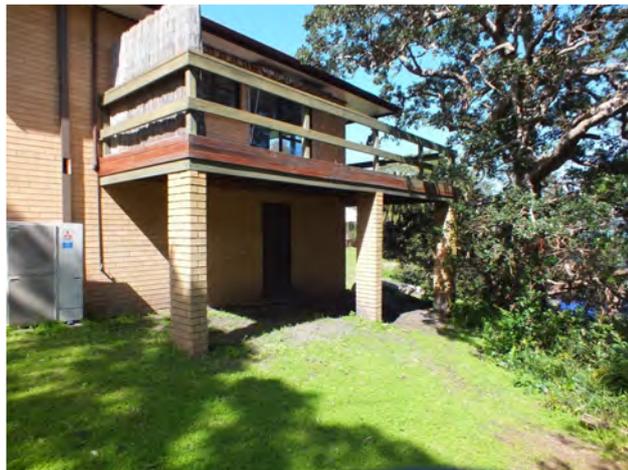
Figure 6.5 Two-storey building, constructed on an Aboriginal shell midden contained above rock shelf. View to south east.

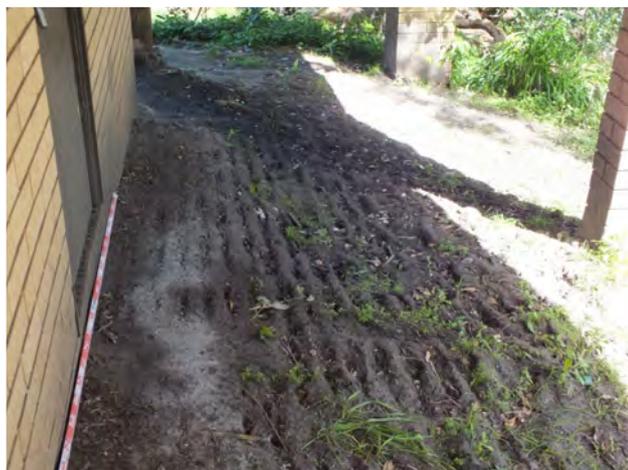
Figure 6.6 View to south, beneath first storey balcony of disturbed midden.

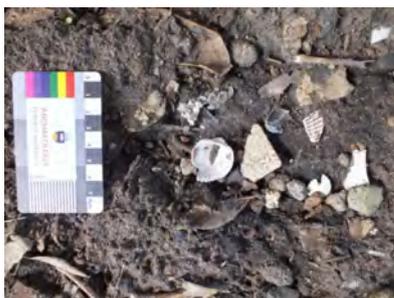
Figure 6.7 Disturbed shell midden material beneath balcony, mixed with modern shell, glass and ceramic fragments.

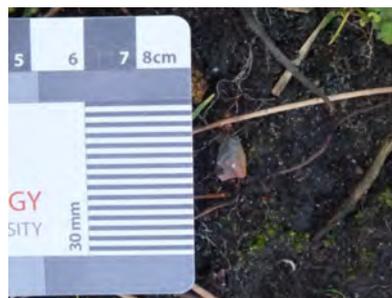
Figure 6.8 Detail of silcrete flake in exposed patch of soil below stone shelf.

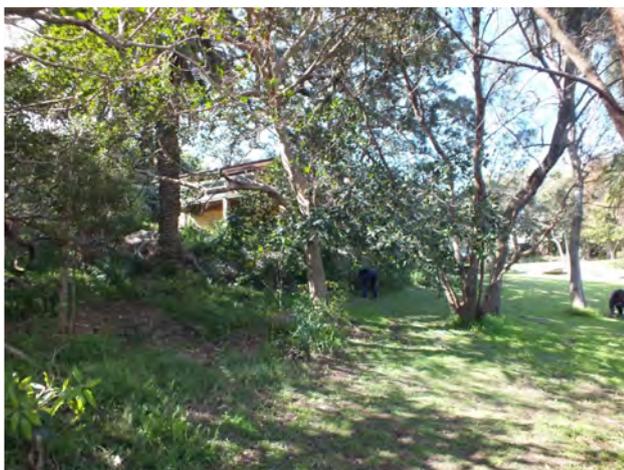
Figure 6.9 Scattered shell material was observed in exposed patches of lawn downslope from rock shelf. View to north east.

A high quantity of shell material was observed throughout the site, despite the construction of various buildings and car parking areas across the Hungry Point Reserve. This included Aboriginal midden material in both disturbed and undisturbed contexts, as well as redeposited shell in garden beds and as reintroduced fill for the installation of services.

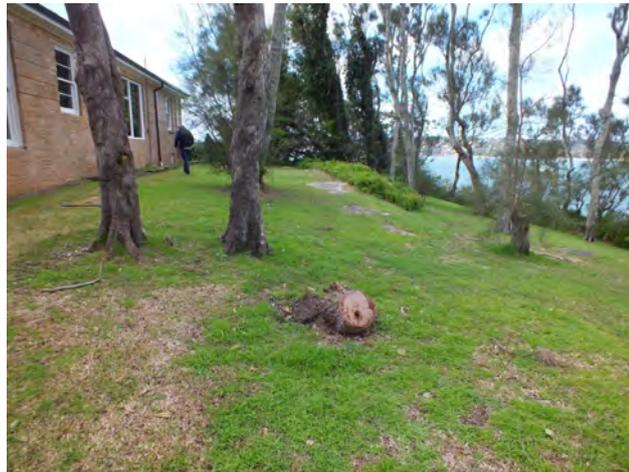
Figure 6.10 Area 2, comprising shell midden site CB 1. Shell is contained above rock shelf. View to east.

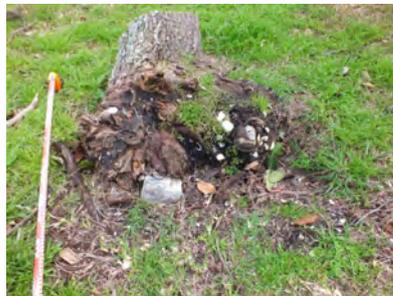
It is clear that the shell material has been disturbed by the construction of Building 1 and the installation of associated services. Eroding shell is visible along the eave dripline immediately adjacent to the building, and in the roots of an upturned tree stump (Figure 6.10 to Figure 6.12). The most

Figure 6.11 Sydney cockle, Hercules whelk and snail shell fragments visible in roots of upturned tree. View to south.

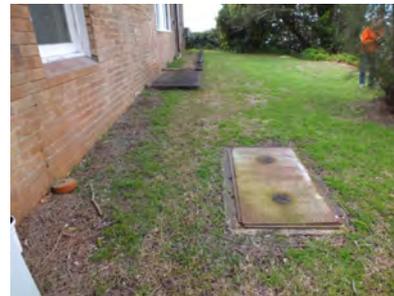
Figure 6.12 Midden material, visible in exposed ground along eave dripline, truncated by Building 1 and other services. View to east.

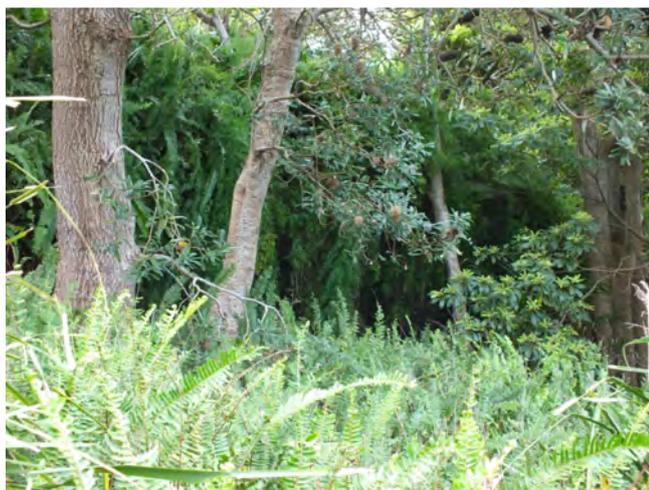
A substantial rockshelter was observed along the eastern foreshore overlooking Salmon Haul Bay (Waypoint 5). The shelter is located amongst dense vegetation at the base of a rock shelf in close proximity to Building 15 (Figure 6.13). No midden material was visible on the surface of the rockshelter floor; though refuse in the form of glass bottles, plastic and modern shell suggests the shelter was used recently. A thick deposit of rich black soil was noted however, and it is possible that the shelter retains subsurface archaeological deposits (Figure 6.13-Figure 6.15).

Figure 6.13 East facing rockshelter amongst dense vegetation, near Building 15. View to north east.

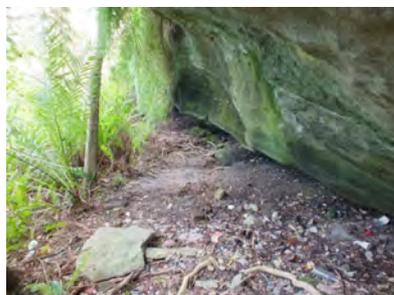
Figure 6.14 Floor of rockshelter with evidence of recent use. View to south west.

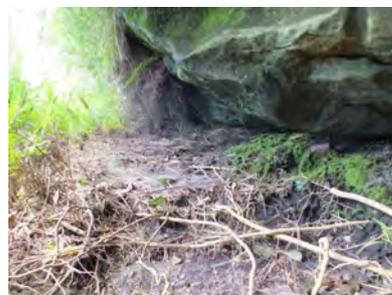
Figure 6.15 Thick deposit of soil along rockshelter floor. View to southwest.

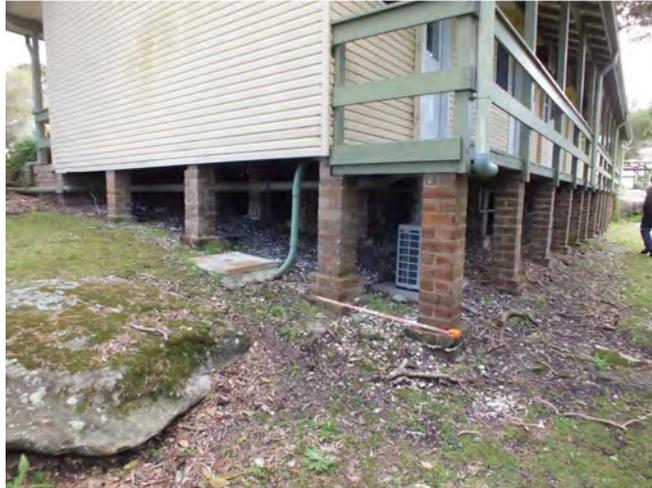
Figure 6.16 Area 3, characterised by shell midden site CB 15. View to north west.

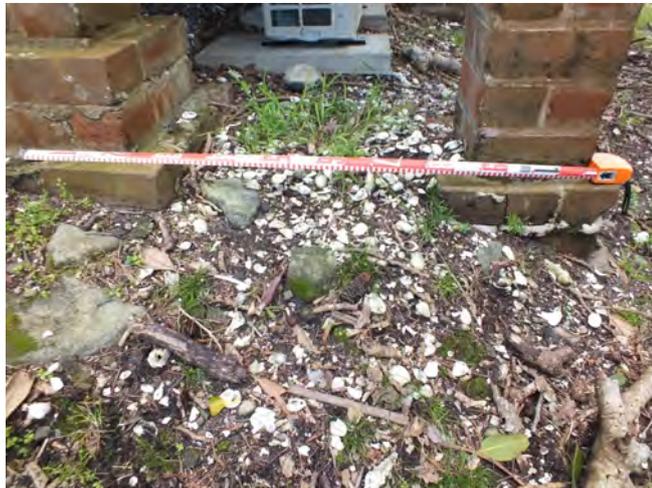
Site CB 15 was initially identified by Laila Haglund as an 11x7m shell midden that included shell, bone (aquatic and terrestrial), stone and glass artefacts and at least one human burial. Extensive midden material was observed in the exposed ground surface beneath Building 15. The deposit comprises densely packed shell in a black sandy soil matrix, and is predominantly made up of Sydney cockle with occasional Hercules whelk. During the current survey, it was confirmed that the midden, though partially disturbed by the setting of brick pillars and the dumping of surplus concrete, appears to have been relatively undisturbed at its southern extent (Figure 6.16-Figure 6.17). However, it should be noted that modern Abalone shells were clustered to the north of the midden (Waypoint 7) and should not be confused with Aboriginal midden material. To the east of Building 15, the area is characterised by sloping lawn and formal garden planter boxes; and thus no evidence of previous archaeological investigation or midden material could be seen (Figure 6.18).

Figure 6.17 Extensive shell midden material beneath Building 15, comprising mostly cockle. View to north.

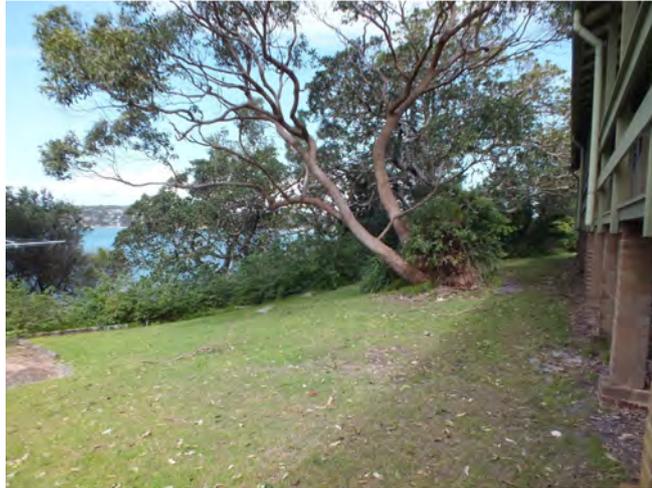
Figure 6.18 Sloping lawn area to east of Building 15, which includes planter boxes. View to south east.

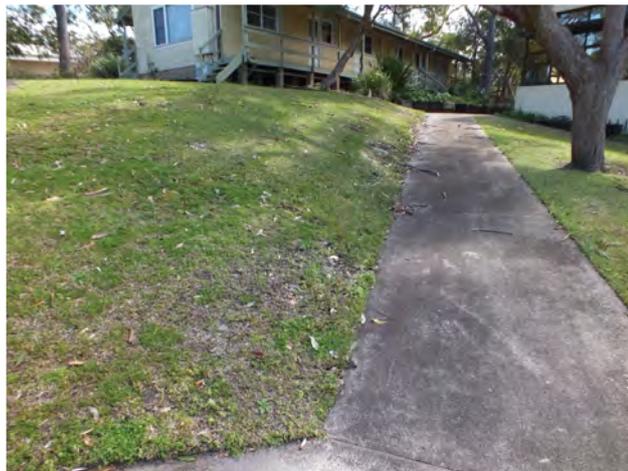
Shell midden material was also observed in the exposed ground surface beneath Building 13 (Waypoint 9), though it should be noted that this material appears to have been partially disturbed by the dumping of modern building material and refuse, including timber stakes, stone pebbles and coarse river sand. The midden is characterised by moderate concentrations of Sydney Cockle in a black sandy matrix. Eroded, fragmentary shell material was also observed at the base of a slope leading down from Building 13, in an area of exposed ground surface at the top of a stone ridgeline (Waypoint 8). The extent of the midden below Building 13 is difficult to determine, though it is likely to be confined to the top of the ridgeline.

Figure 6.19 Area 4, comprising midden material above a stone ridgeline. View to north west.

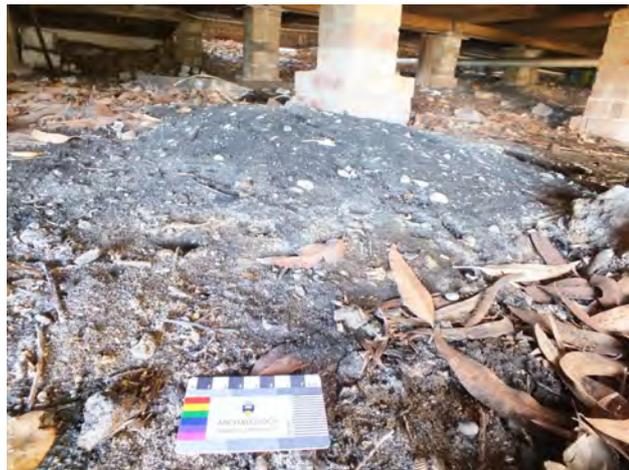
Figure 6.20 Disturbed shell midden material beneath Building 13. View to west.

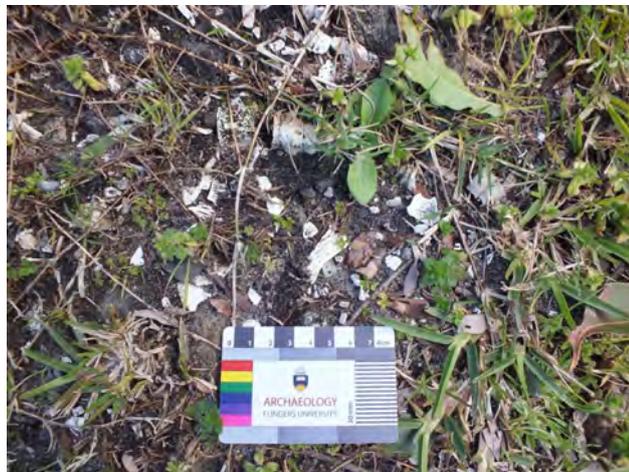
Figure 6.21 Eroded shell at base of slope above stone ridgeline

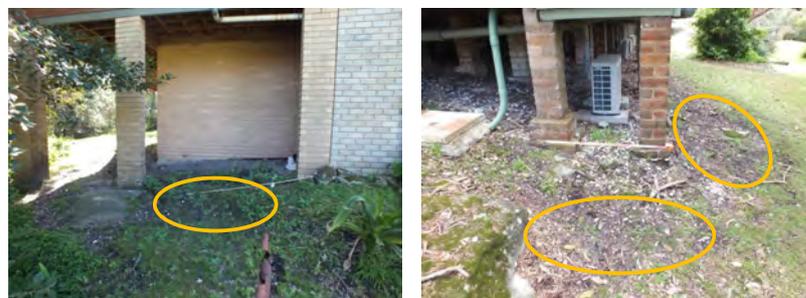
Figure 8.1 Examples of areas in which planting is recommended to prevent erosion and stabilise the midden.
